International Conference **DAM SAFETY-2025**

Latest Technologies for Rehabilitation and Dam Safety

Workshop on

Grouting Technologies in Rehabilitation of Dams

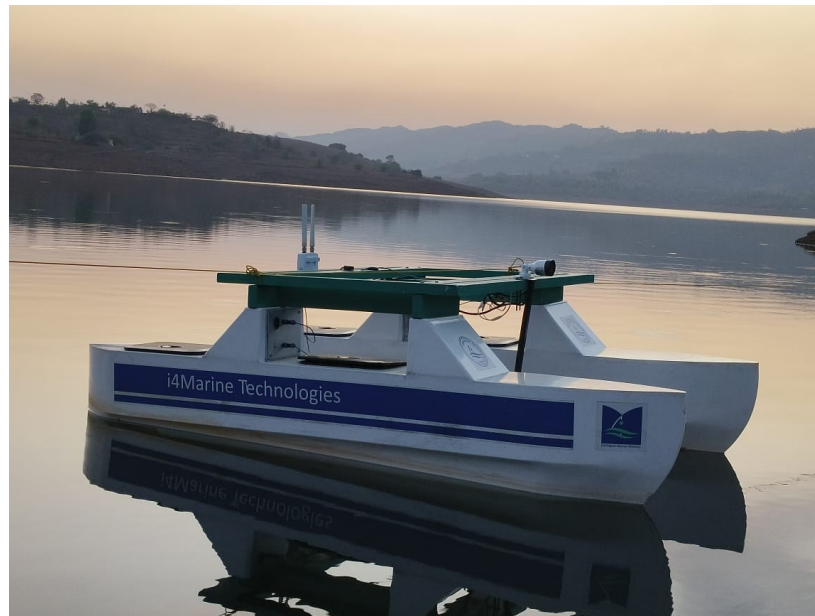
The Autonomous Surface Vehicle (ASV) – Aqua Scanner (fig 1) can be programmed to traverse over or scan a water body measuring different parameters in real-time. AquaScanner was used to demonstrate its capability in bathymetric mapping of Panshet dam reservoir near Pune. The platform fitted with an Echo Sounder, GPS, 3 axis accelerometer measuring roll pitch and yaw, heading sensor measuring the direction with respect to North, was preprogrammed to undertake waypoint navigation in a lawn mower fashion over the water surface. The mission was loaded onto the platform controller and commanded to be executed. The intelligence provided in the platform carried out the traversal autonomously over the path collecting data on real time. The data is stored on-board as well as transmitted using Radio Frequency on real time to the Ground Control Station placed 2km away.

Figure 1: AquaScanner – Autonomous Surface Vehicle

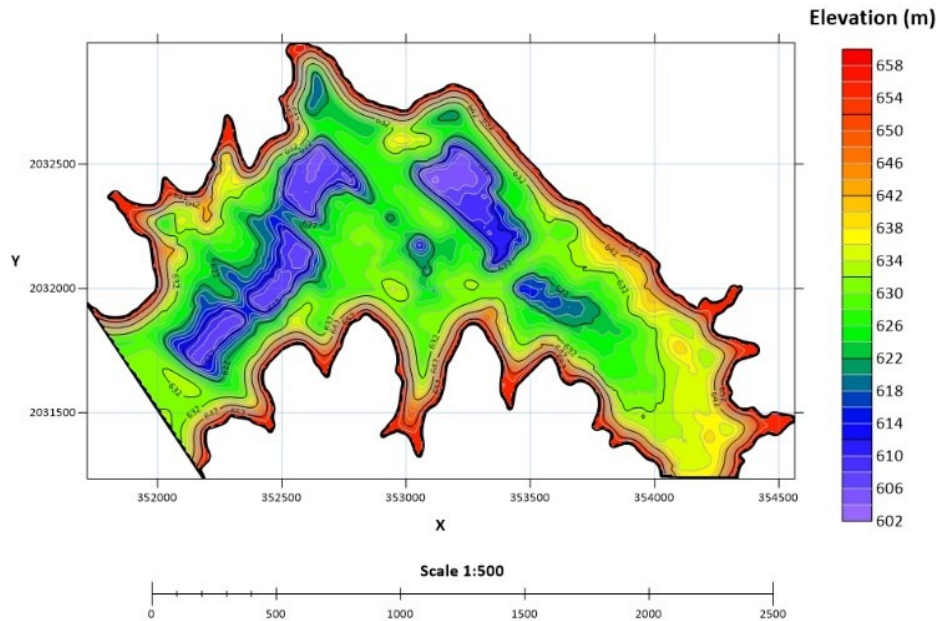
On completion of data collection, the same was processed to generate contour maps as well as 3D terrain of the resulting area. Figure 3 shows one such plot processed from the data. Dam volume capacity, water spread area and processed numbers generated. The details of the same have been outlined in the report prepared (Ref. 1)

Figure 3: Underwater Terrain map of the area scanned

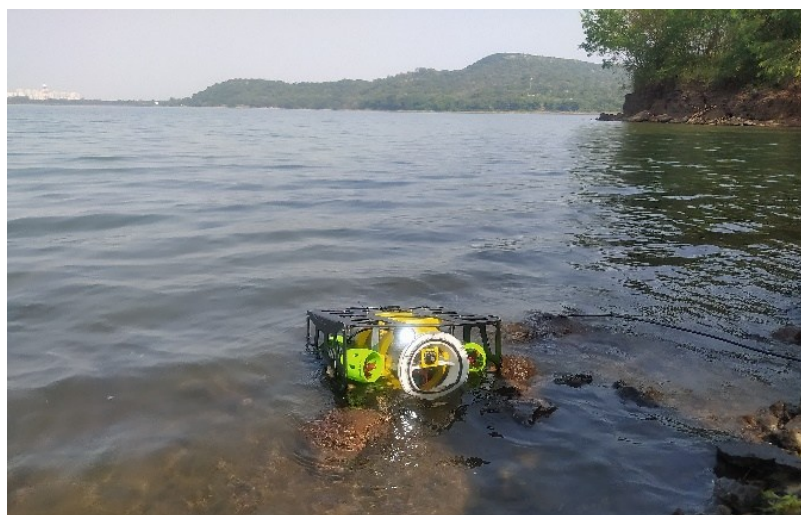
The Underwater Remotely Operated Vehicle AQUANAUT-30, Figure 4, has been designed and developed as a platform for underwater visual inspection. It is an Underwater Remotely Operated Vehicle that carries sensors for navigation and propulsion as well as a controller to provide the user with the feedback of the path being traversed in real time by measuring the depth and heading of the platform on real time. The platform can be enhanced with other sensors for diverse applications aimed at marine geology, chemistry, living resources and for constructions in seas and for inland applications towards pollution mapping, aquaculture amongst many more. Another area is the development of deck side hardware and software for higher level AquaNaut's versions.

The Aquanaut-30 consists of an aluminium chassis which is the outer frame of the platform thereby providing long life. The Aquanaut-30 is self-contained with its power source, control electronics, communication and navigation hardware placed in its central hull. The Aquanaut 30 has six thrusters placed in such a plane and geometry, thereby allowing four Degree of Freedom (DoF) to the platform. The thrusters are placed within the frame thus protecting them from mechanical damage during operations or mission. The rechargeable batteries provide good endurance necessary during survey.

Figure 4: Aqua Naut 30 at site.

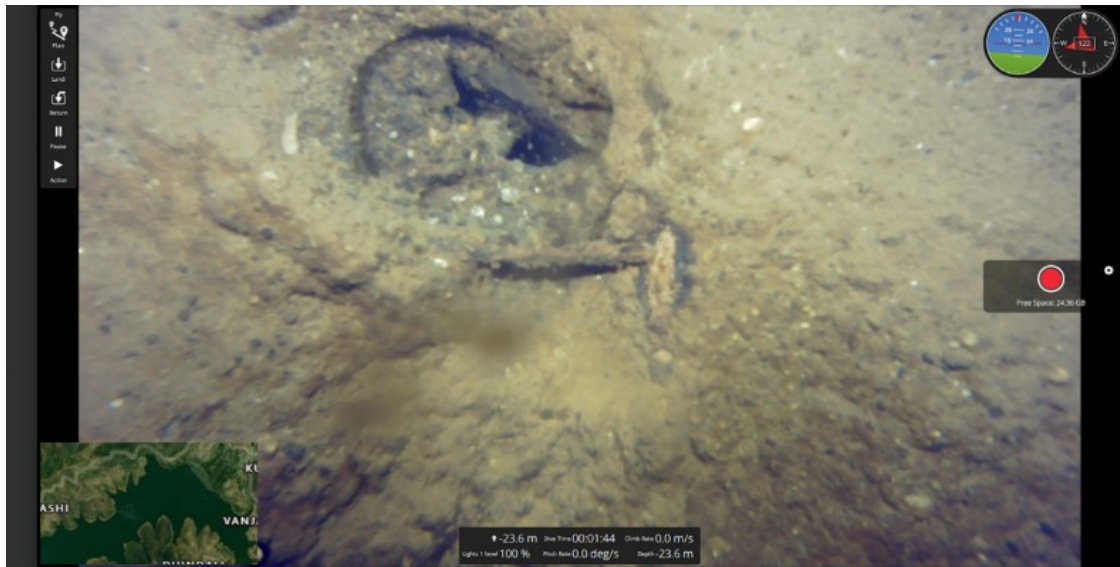
The platform was launched at Varasgaon Dam near Pune to inspect the dam wall for any anomaly. The ROV was tethered and lowered at different pillar location of the dam and the platform dived vertically down to a depth of 30m from the water surface. The resting video is subjected to Artificial Intelligence algorithms for removal of turbidity in the water. This unique feature provides the Dam Safety officials a clear vision of the location being surveyed. One such snap shot from the video at Pillar No 6 at a depth of 23.6m is provided below in Fig 5.

Figure 5: Anomaly Observed at depth of 23.6m at 6th pillar

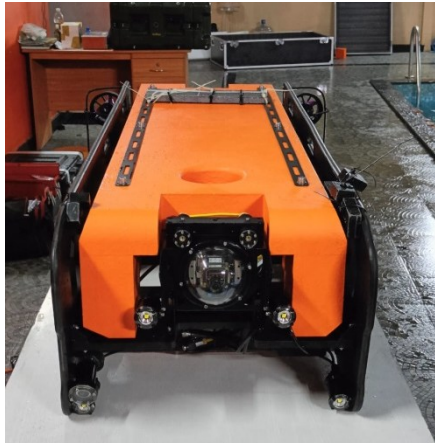
Tunnel Specialist ROV specially designed for tunnel inspections can be used through the manholes for the tunnel inspection. A joystick is used for controlling the ROV during navigation. HD cameras on ROVs assist in obtaining visuals of the interior of the tunnel. When the water is murky, visibility may be low and the images may not be adequate in clarity. Acoustic sensors like imaging SONARs which produce acoustic images, can be used in these circumstances. Each collection of data that the ROV acquires is gathered by the control station.

Figure1: Tunnel Specialist ROV

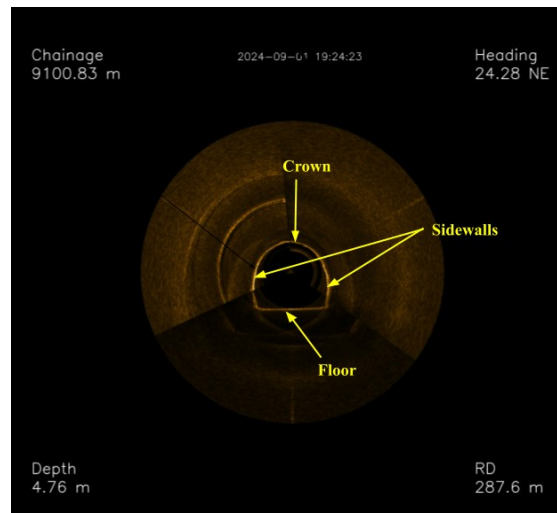
Figure 5: Acoustic SONAR image of Tunnel with marking of Crown, Floor and Sidewalls

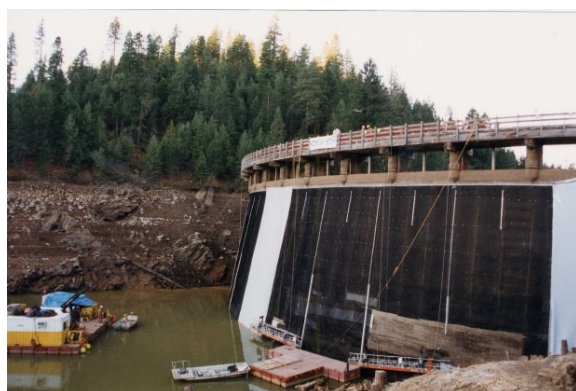
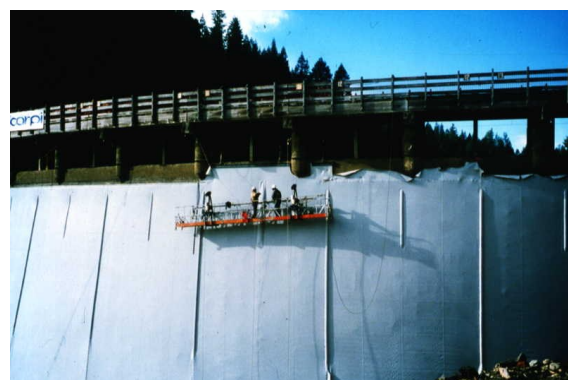
The waterproofing liner is a flexible composite material consisting of a 2.5 mm thick Sibelon® geomembrane providing watertightness, and of a 500 g/m² nonwoven geotextile for puncture protection and dimensional stability. The geomembrane is placed on a full-face drainage geonet, doubled at bottom to form a longitudinal drainage collector conveying water to a transverse pipe discharging downstream. The face anchorage system for the geomembrane consists of an assembly of two stainless-steel profiles, which also act as free-flow vertical drainage pipes conveying water to the bottom collector, and are detailed further on.

Figure 1. Lost Creek. At left, the grey geocomposite sheet under placement over the black drainage geonet, and the first components of the vertical anchorage assembly. At right, the anchorage profiles waterproofed in the dry section. The closer spacing of profiles in the top area can be seen.

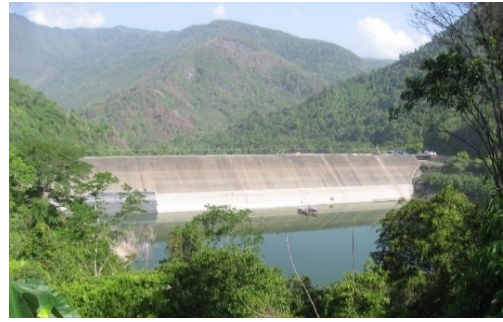
When full-face lining is unpractical for operational or economic reasons, or when leakage comes only from a portion of the dam, a different approach can be used. This was the case at Turimiquire 113 m high Concrete Face Rockfill Dam (CFRD) in Venezuela, used for potable water supply. Already one year after impoundment, in 1988, the dam started leaking and, despite regular repair works carried out over time, leakage kept increasing, eventually reaching 9,800 l/s. Underwater investigation ascertained as main causes of leakage diffused cracks and two craters in the concrete slabs, located in a large intermediate area of the dam that was always submerged. The owner decided to carry out rehabilitation works in a staged manner, starting with the most leaking parts. The geomembrane system was designed specifically in view of future additional areas to be lined. The first stage took place in 2010/2011, maximum diving depth exceeded 50 meters only occasionally, which allowed surface supplied diving. The first-stage rehabilitation works, marked in dark grey in Fig. 2 at left, covered about 20% of the dam face, and allowed decreasing leakage to 2,400 l/s, well below the target leakage for this first intervention, which was 3,000 l/s. This leakage reduction allowed to maintain the dam in service and to gather new funds for continuing the rehabilitation. The second stage works in 2016/2017, marked in red in Fig. 2, covered an additional 5% of the upstream face.

Figure 2. Turimiquire. The grey (2011) and red (2017) areas object of waterproofing works.

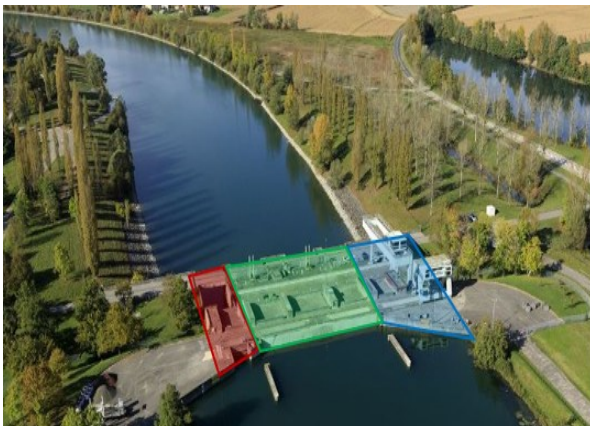
Repair of failing joints or cracks or small defective areas is made with a patented external waterstop. The waterproofing liner is supported over the joint/crack/cavity by one or more flexible or rigid layers, and sealed at the periphery by a perimeter seal watertight against water in pressure, of the same type adopted for face repair. The most recent project of this type was carried out in 2022 at Brégnier Cordon, a 17 m high dam on the Rhône River in France, a composed structure consisting of a left block housing the outlet for floating debris (in red in Fig. 5), of a central block with the powerhouse (in green), and of a right block housing the annex building (in blue). The external waterstop was installed underwater at joint BC3, between the powerhouse and the annex building, from the top of the parapet wall (elevation 219.50 m) down to the bottom (elevation 208.20 m), after removal of the rockfill channel bottom protection and silty fill. The challenges of this project were a complex geometry with 90° and 45° corners and a large opening, the speed of the water and the suction ascertained by a previous inspection, the presence of large floating debris with branches weighing up to one ton; these conditions called for ad hoc precautions before and during installation, for robust materials, and for a suitable cover layer to protect the geomembrane from possible heavy impacts

Figure 5. Brégnier Cordon. The blocks of the dam, and joint BC3.

Very flexible materials were needed for the sacrifice and waterproofing layers to adapt to the geometry and to the possibility of future structure movements; at the same time, the sacrifice layer had to be strong enough to support the waterproofing liner and avoid it collapsing into the large opening. The waterproofing liner is of the same type adopted at Turimiquire, the sacrifice layer is a high-tech geosynthetic with a high elasticity modulus. From crest to the elevation where the geometry at the joint changes, the waterproofing liner is covered by 50 cm high stainless-steel plates, designed, connected and anchored to allow opening/closing of the joint; from there down to bottom, the waterproofing liner is covered by a nonwoven geotextile, to provide protection in the event of strong impacts or puncture by the rockfill subgrade. Most of the installation was carried out underwater by surface-supplied divers, after securing of the underwater work area, necessary to carry out works concurrent with hydropower production.

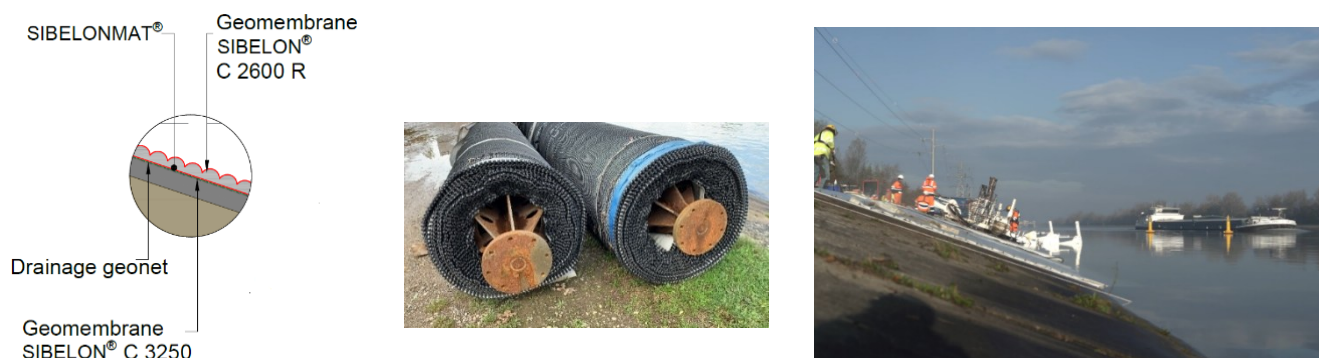
After a few years of study, testing in the laboratory and full-scale testing in real structures, both in still and flowing water conditions, the Sibelonmat® was adopted at three pilot projects, in Egypt and Italy for irrigation canals, and most recently, in 2020, at the Kembs embankment, which is part of the Grand Canal d'Alsace, a 150 m wide, 8-10 m deep and 52 km long navigation canal in France. The Sibelonmat® at Kembs was installed on the existing deteriorated concrete facing

of one embankment, over a length of 50 m, from crest down to about elevation 236.3, i.e., on about 28 meters of slope, covering 80 slabs and spanning 26 vertical and horizontal joints, while the canal was in full operation. Five panels, each 10 m wide and 28.4 long, were designed and prefabricated to waterproof the area, in total 1,445 m².

Figure 6. Kembs. Cross section of the Sibelonmat®, rolled void mattresses ready for installation (the drainage geonet is the black material, and the integrated zips is visible along the edge of the mattresses), and the Sibelonmat® deployed on the slope with navigation ongoing during underwater works.

The Sibelonmat® mattresses were fixed at top by a stainless-steel seal watertight to rain and waves. The side peripheries have a standard watertight stainless-steel perimeter seal, the bottom perimeter seal is an L-shaped stainless-steel profile that also acts as support for the filled mattress. Adjoining mattresses were joined by pulling the zips from the dry. After the panels had been joined, via the integrated grouting hoses the hollow space between the two geomembranes was injected from the crest with cement grout, thus preventing loss of cement in the water, providing a solution totally respectful of the environment. The project was awarded the 2022 Golden Innovation Award by ICOLD, the International Commission on Large Dams. The first results for the Sibelonmat®, as monitored by the owner EDF – Electricité de France, are encouraging and confirm the interest in developing this kind of technique.

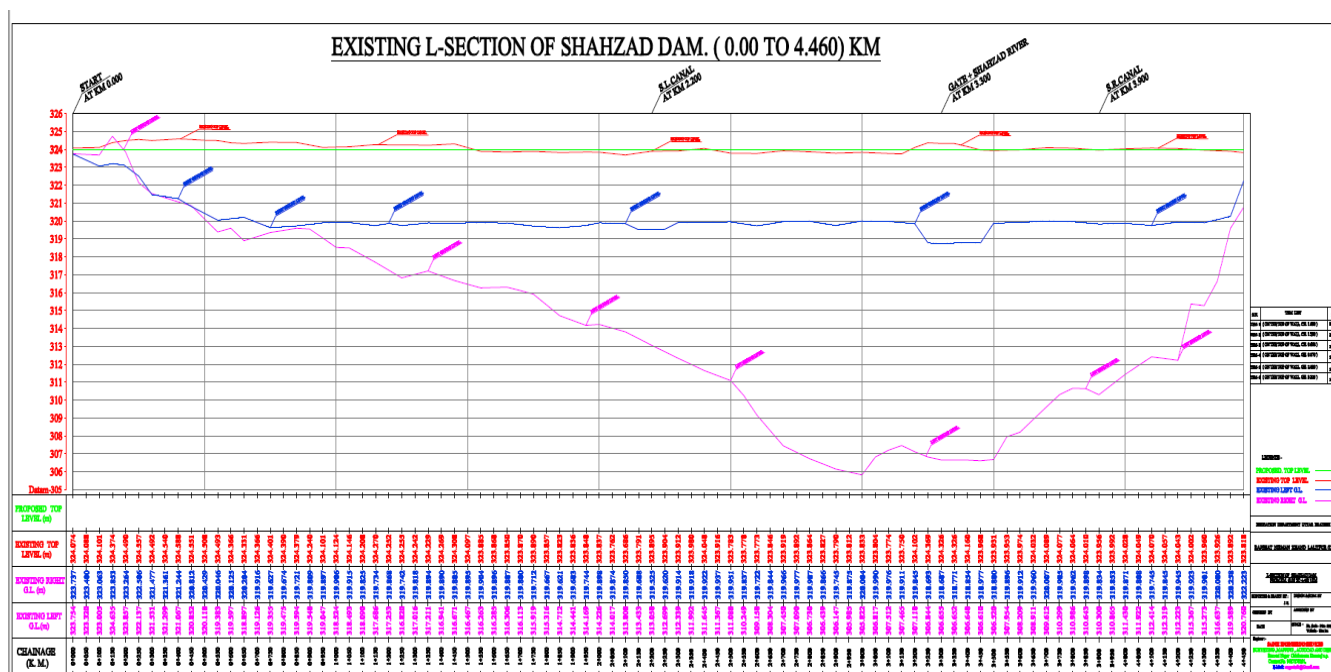
Figure 6.: L-Section of Shahzad Dam

The L-section and gallery RL of the Shahzad dam has been given in Figures 2 and 3.

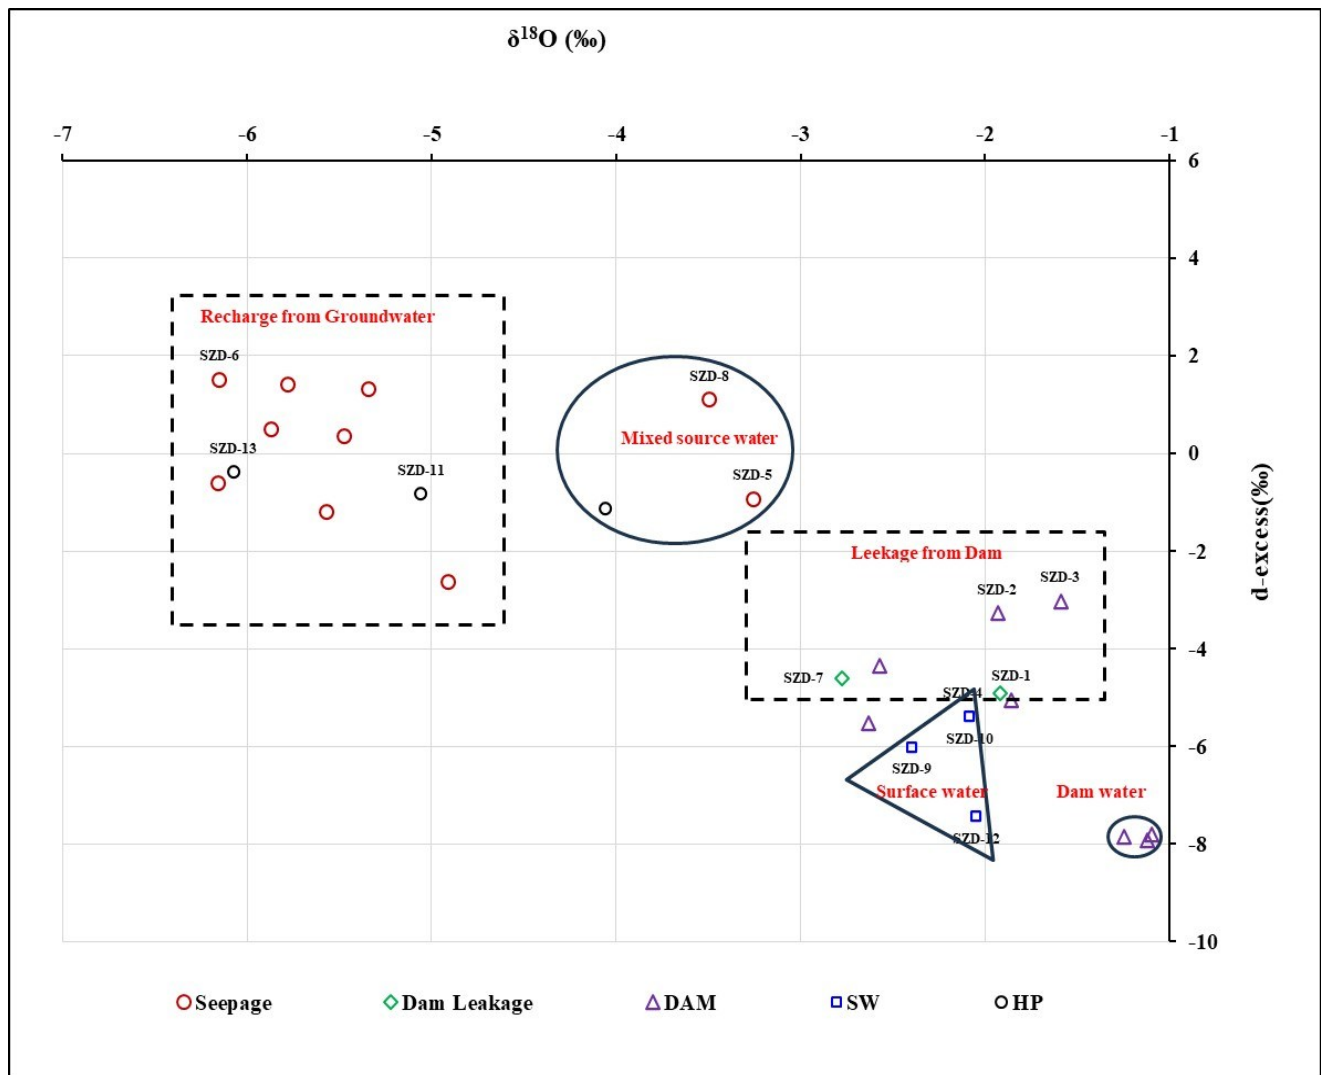
E- It is clear from the Figure 4 that a low to medium correlation exists between *D*-excess and $\delta^{18}\text{O}$ values which suggests that evaporation shifted the enriched $\delta^{18}\text{O}$ and reduced the *D*-excess values in case of surface water. The same has been observed in case of the water samples from the dam water. The reduced *D*-excess in surface waters is resulted

from kinetic isotopic fractionation during phase changes, which could be ascribed to the differences in diffusion rates among H₂O molecule isotopologues. There is overlapping in the samples of leakage water, surface water and dam water which suggest a possible same source and groundwater recharge in seepage water.

Figure 4. Plot between $\delta^{18}\text{O}$ and d-excess of water samples from various sources

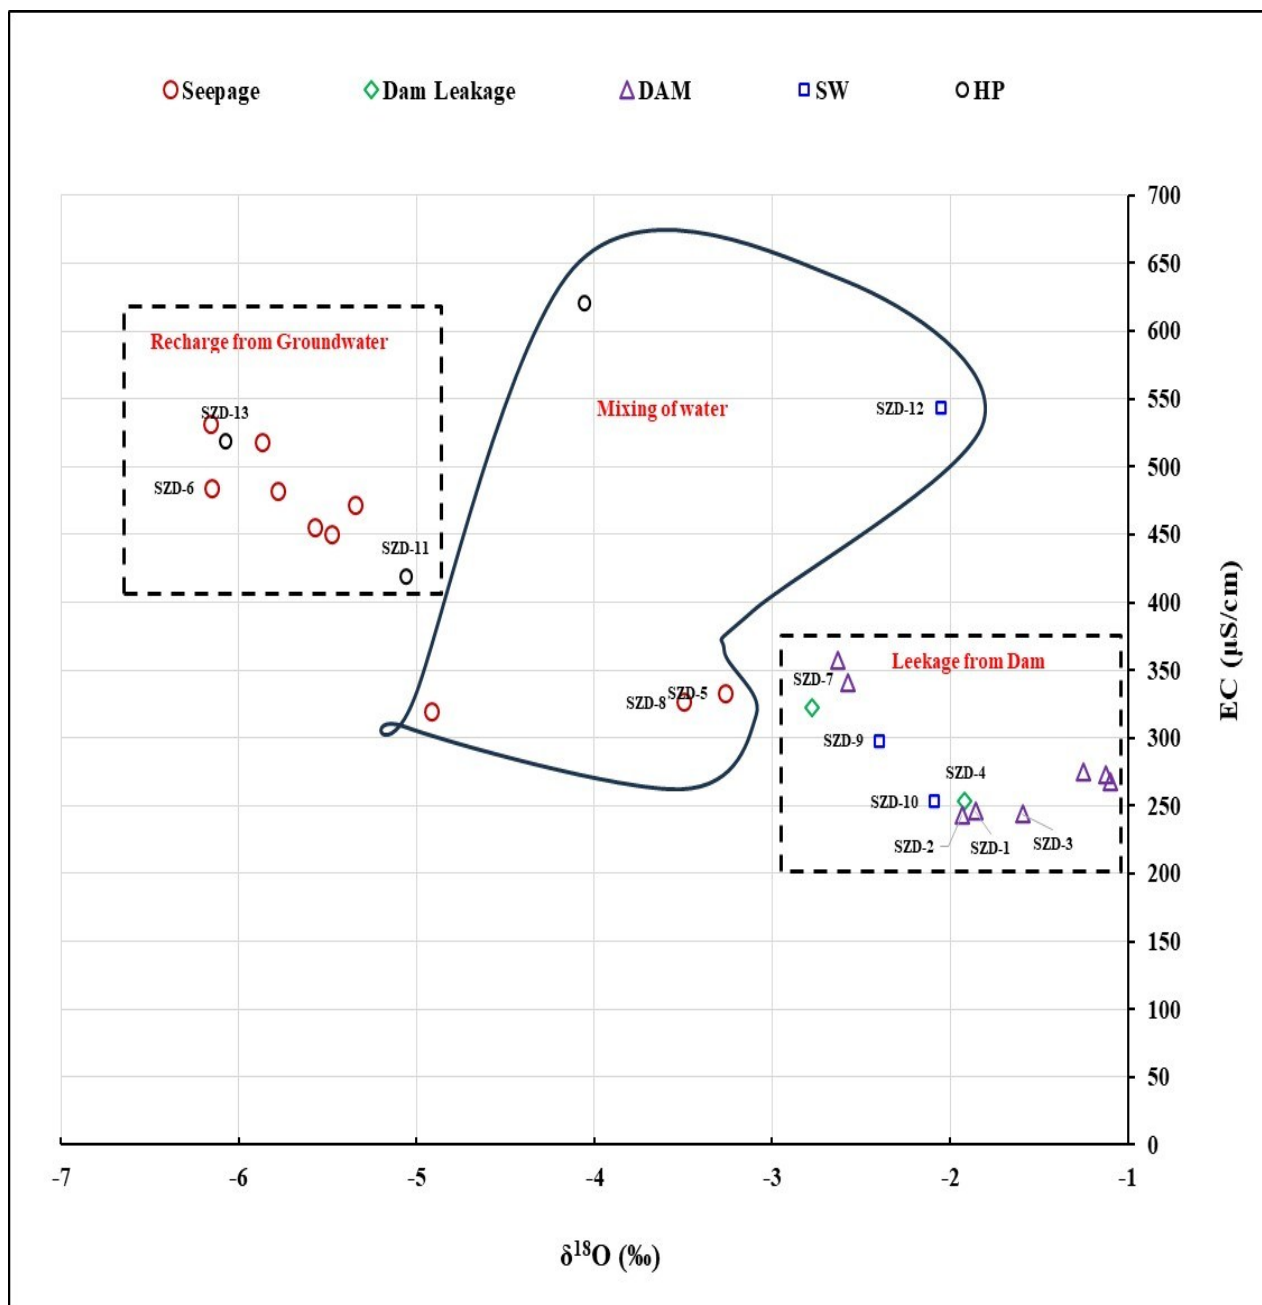
Correlation between $\delta^{18}\text{O}$ v/s EC is shown in fig. 5 which indicated that the more enriched values of $\delta^{18}\text{O}$ resulted due to evaporative enrichment as dissolution does not affect the isotopic values (only EC value increases). It has been seen that groundwater has higher EC and depleted $\delta^{18}\text{O}$ values while reservoir samples have less EC and enriched $\delta^{18}\text{O}$ values. The signature of the reservoir water and leakage water matches as both have almost same EC and $\delta^{18}\text{O}$ values.

Figure 5. Plot between $\delta^{18}\text{O}$ and EC of water samples from various sources

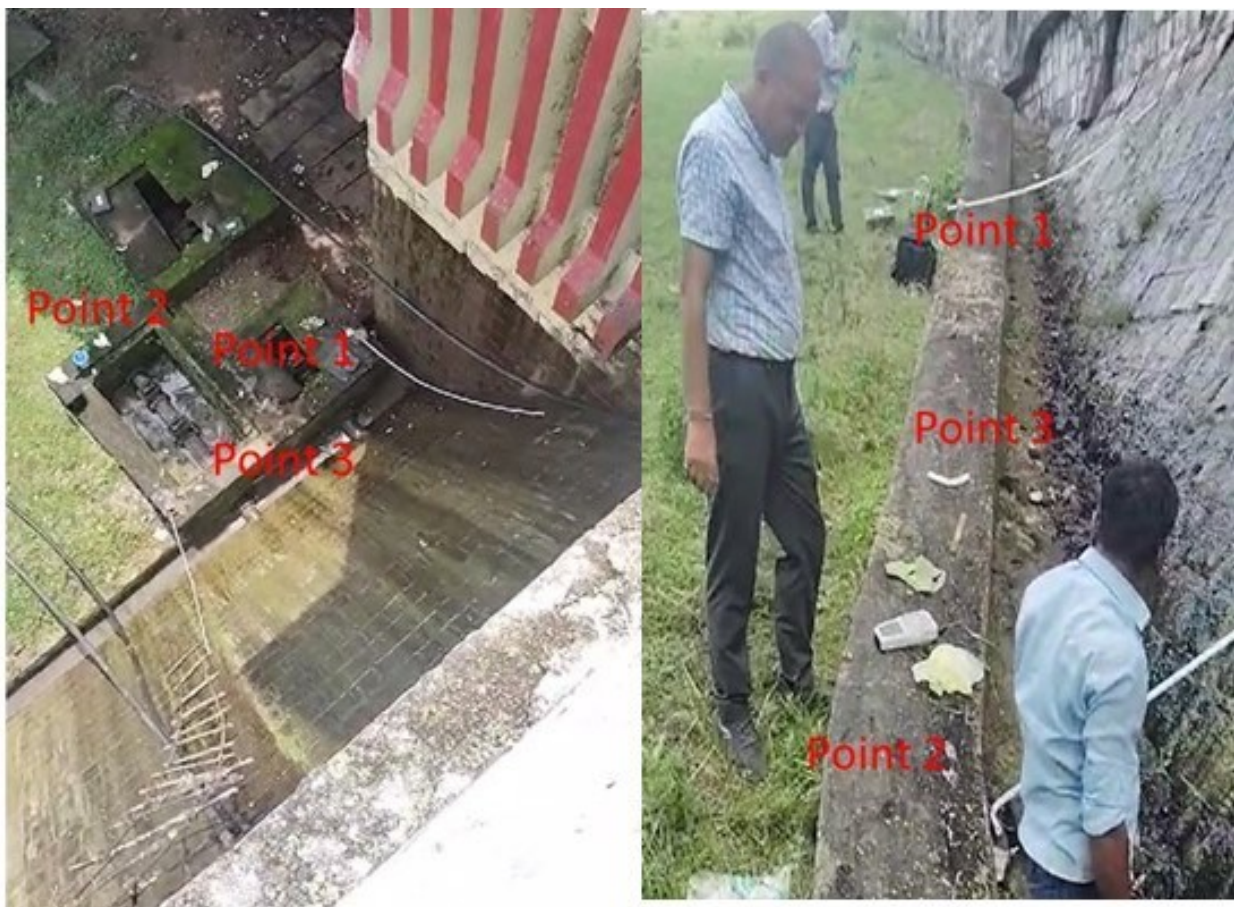
The second experiment was conducted on August 17, 2024. Salt bags containing 20 kg of salts were immersed at a specific depth approximately at 318 to 319 MSL of the reservoir on left and right flanks, respectively. EC was measured in leakage water at different points (figs. 7) in left as well as right flanks at different points of the leakages and the measurements are shown in the figures 8 and 9.

Figure 7. Points for EC measurement on left and right flanks

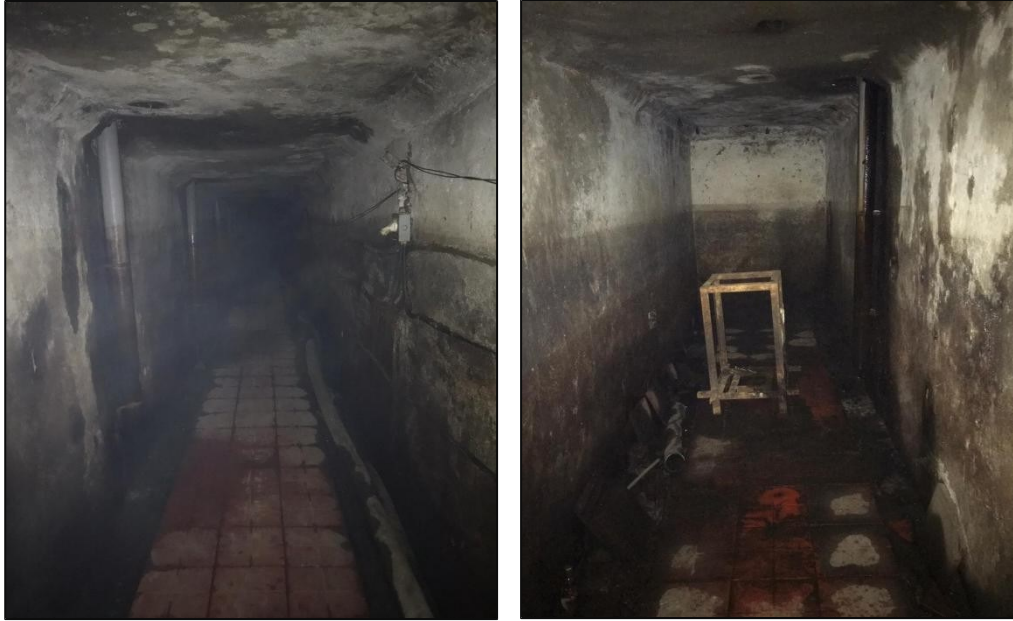
Figure 4 Observation of dryness in inspection gallery in 2016 - Totally dry

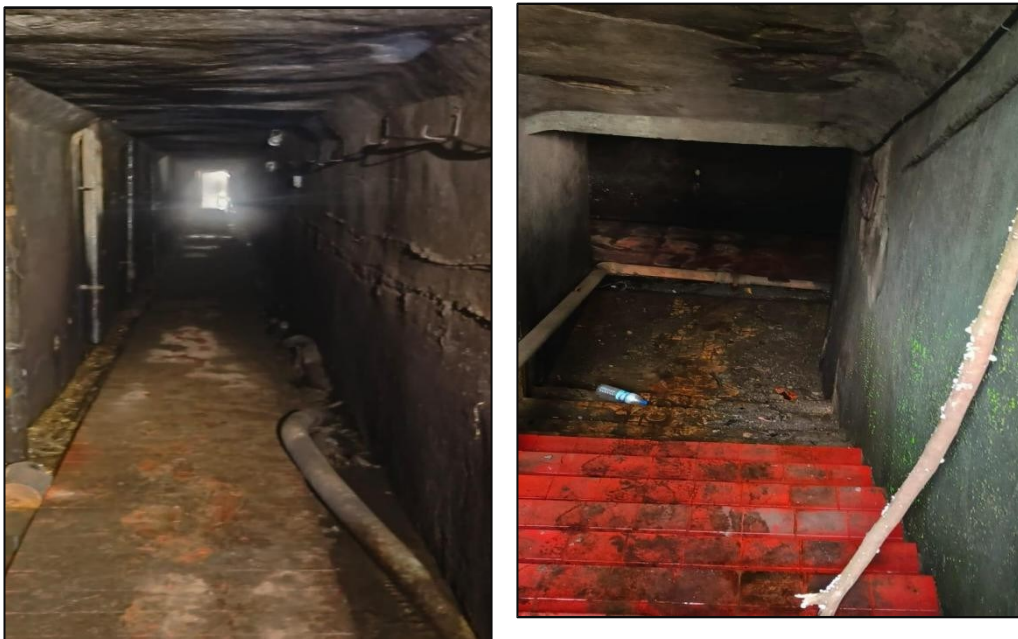
Figure 5 Observation of dryness in inspection gallery in 2024 - Totally

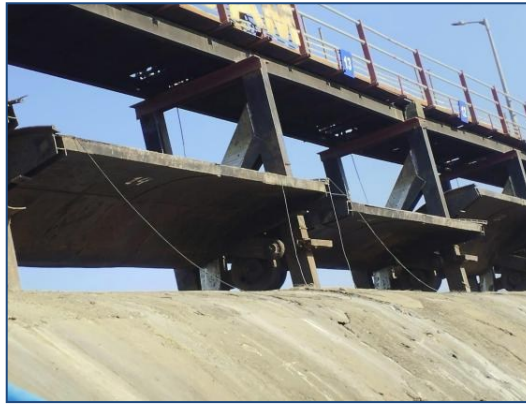
Visual inspection of the gates in later part of 2023 revealed that, the corrosion protection system provided to gates and its accessories is worn out & fully disintegrated due to excessive corrosion.

Fig 1. Excessive Corrosion in 2023

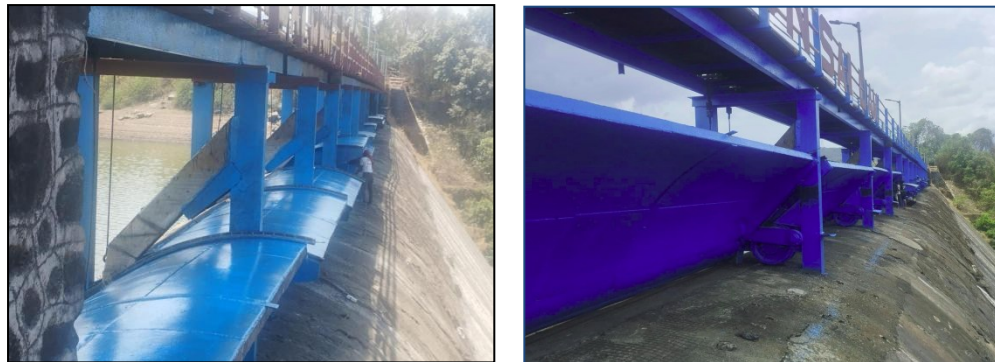
Figure 4. After Completion of Corrosion Protection Work of All Gates

The performance of the treatment to the gates was monitored after monsoon of 2024 through visual observation, The performance of the coating system will be monitored using half cell potential & cathodic disbondment testing.

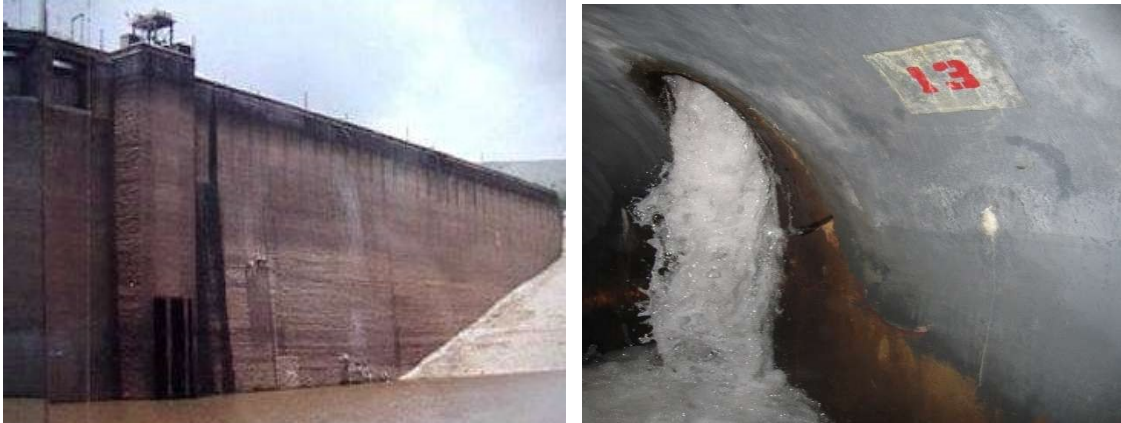
Figure 1&2 Condition of the Kadamparai Dam before Geomembrane Installation

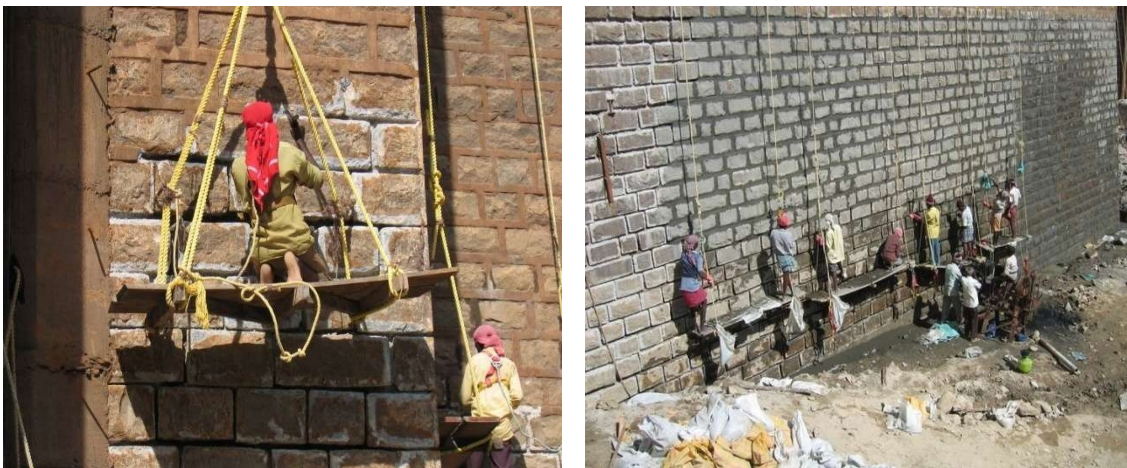
Figure 3&4 Conventional Racking and packing treatment methods carried out

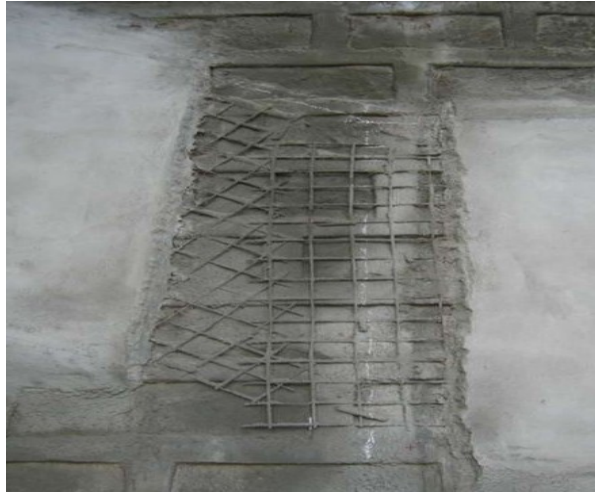
CARPI took over the site by end of November 2004 and started surface preparatory works which includes hydroblasting the upstream face area which had loose mortars. The removed mortar joints were repacked with new mortar. It is important to mention that the geomembrane system has several steel anchors at designed intervals which needs a fairly stable subgrade. The base of each of the 12 vertical joints in the masonry has been drilled and then grouted to avoid water by-passing the perimeter seal of the geomembrane system. The places where anchorages has to be laid is treated with a strip of mortar for even surface.

Figure 5 Surface Preparation by Shotcreting with minimum reinforcement

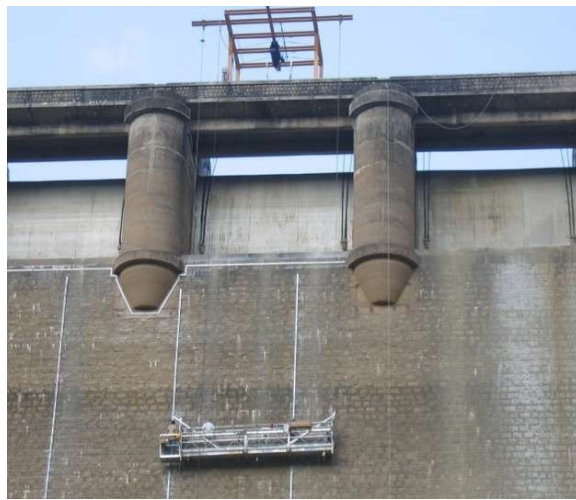
Figure 6 Laying of Vertical anchorage lines minimum reinforcement

The vertical anchorage lines at designed spacing is laid throughout the section initially. The stainless-steel profiles which fasten the geocomposite to the face of the dam, are adjusted to follow the shape of the upstream face and fastened by chemical anchors placed in the stone masonry. As masonry surface has many undulations and sharp surface than other concrete surfaces, to protect the geomembrane from puncturing, a sacrificial layer of Geotextile, 2000 g/m² is laid initially. Then the waterproofing liner SIBELON CNT 3750, consisting of a 2.5mm thick thermoplastic SIBELON membrane heat bonded during fabrication to a non-woven needle punched 500g/m² of polypropylene geotextile is rolled. The rolls of geo-composite are overlapped and welded together by process of heat seaming. After welding all geo-composite panels together, the external tensioning profiles are placed over the geo-composite and connected to the lower profiles laid earlier. This anchorage system is patented by Carpi. The geomembrane is held at the crest consists of a batten strip, placed over the surface smoothened with mortar. The external tensioning profiles are covered by a PVC geomembrane strip SIBELON C3900 which is heat welded to the parent geomembrane below.

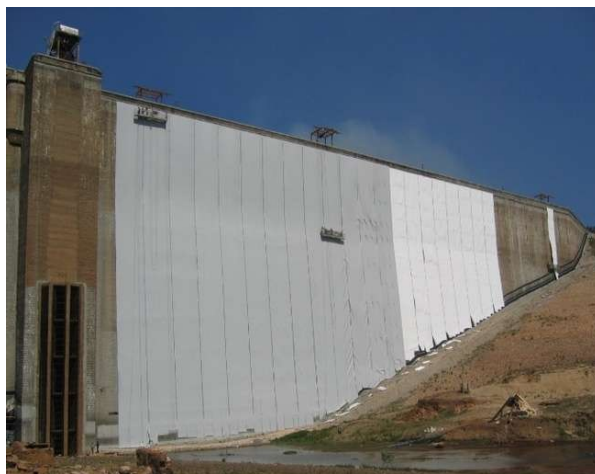
Figure 7 Placement of Geocomposite over Geotextile layer

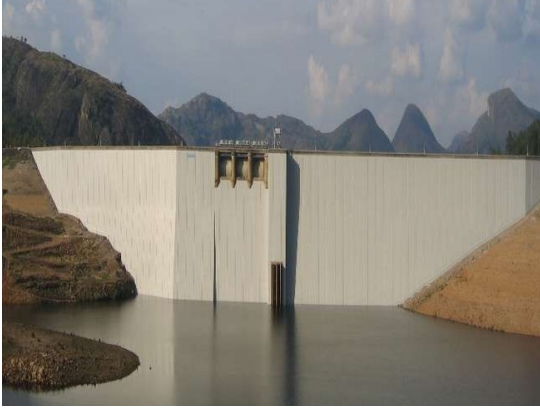
Fig 9 Kadamparai Dam after Rehabilitation works gallery

The complete geomembrane system is installed in 3 months' time laying an area of 17,300 m². Impounding after work began on April 12, 2005. After 10 years of limited operation (well below the full level), with an experienced leakage of up to 38,000 lpm, after rehabilitation is again at full supply level with rate of leakage reduced to 80 lpm. Now its approaching 20 years of successful operation with no further increase in leakage testifying the credibility and longevity of the system.

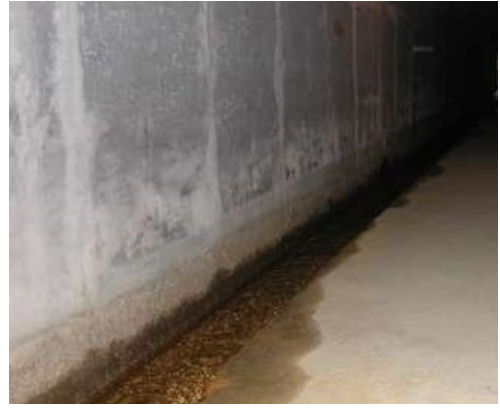
Fig 10. Dry condition of Inspection gallery

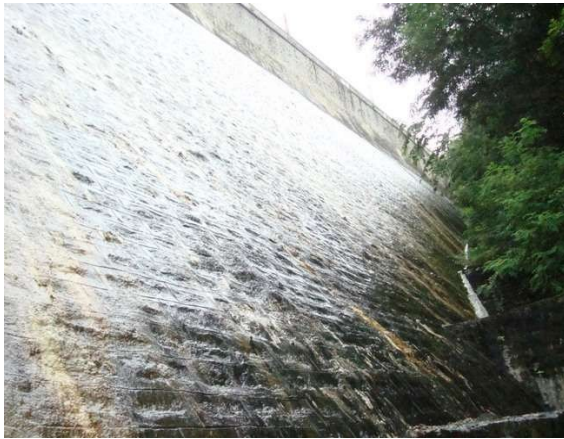
The major problem encountered in the dam is a heavy seepage and leaching through the left flank portion with a maximum seepage of 743 LPM in 2009 at FRL. and choked vertical shafts and foundation drains in turn resulting in saturation of dam body which were observed on the downstream side of the dam.

Fig 11. Flooded downstream surface

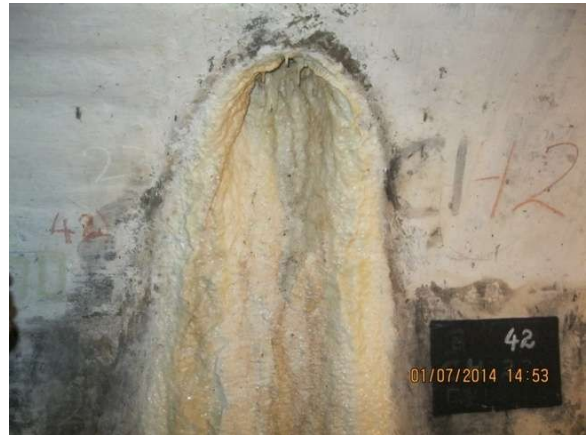
Fig 12. Choked Drainage Shaft

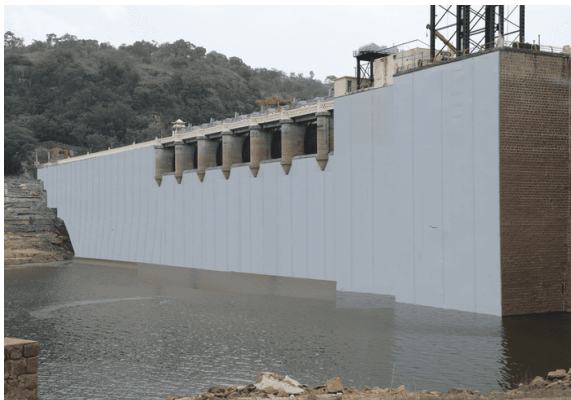
Fig 15 Servalar Dam After Rehabilitation installation

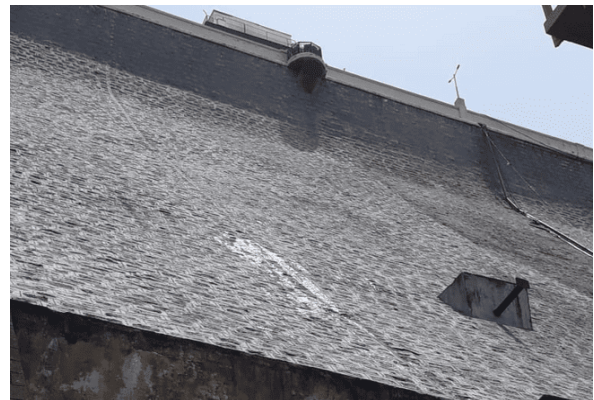
Fig 16. Dry downstream surface after

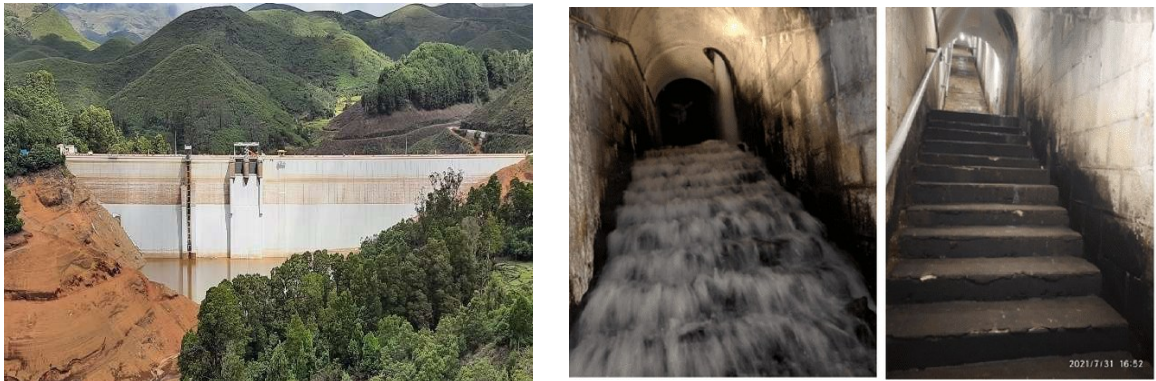
Fig 17,18,19 Upper Bhavani dam after installation

The rehabilitation system adopted in Upper Bhavani is the widely used technique mentioned in bulletin 135 of ICOLD 2010 similar to Kadamparai and Servalar. The geomembrane used here is SIBELON CNT 4400, consist of 3mm thick geomembrane heat bonded to a non-woven needle punch 500g/m² polypropylene geotextile. All anchorage lines are smoothened by applying a layer of mortar over which tensioning profiles are laid at a spacing of 5.70m. An anti-puncturing geotextile 2000g/m² is covered as a sacrificial layer over which the membrane is laid and seamed. At crest 50x3 flat stainless steel batten strip tied to the dam and in submerged peripheries 80x8 mm flat batten strip with resin is anchor rods is done. The drainage and the optic fibre cable monitoring system is followed as done in Kadamparai dam.

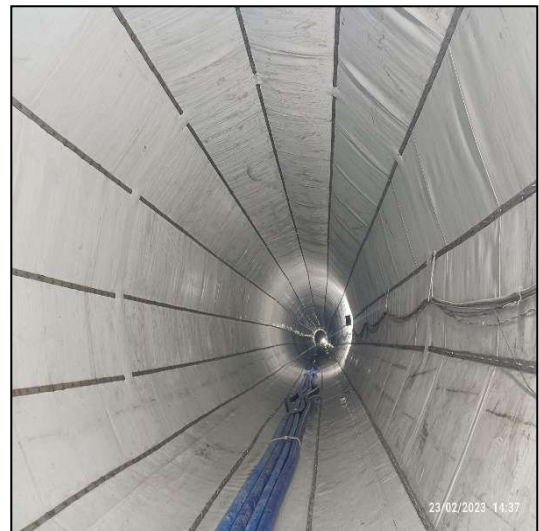
Fig 22,,23 Before and After Installation

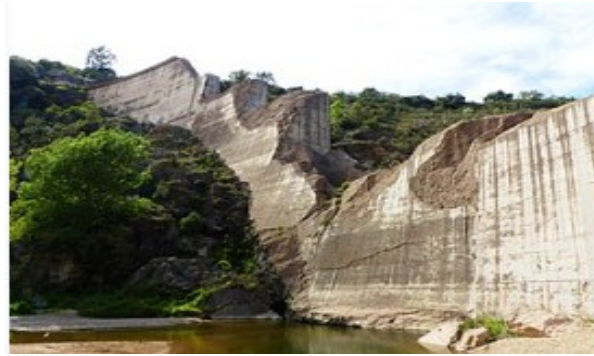
Figure 2: Ruins of Malpasset Dam

The construction of Malpasset Dam in France began in April 1952 and was finished in 1954. On December 2, 1959, the Malpasset Dam in France failed catastrophically after a combination of poor construction materials and design flaws led to the collapse of the dam's structure.

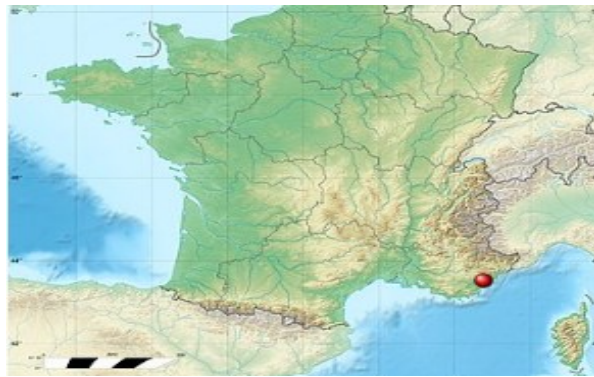
Figure 3: Location of Malpasset Dam

Dam was built with a faulty grout curtain and inadequately compacted materials, which weakened its ability to withstand pressure from water stored behind it. The collapse of the dam resulted in 423 deaths and significant damage to surrounding towns.

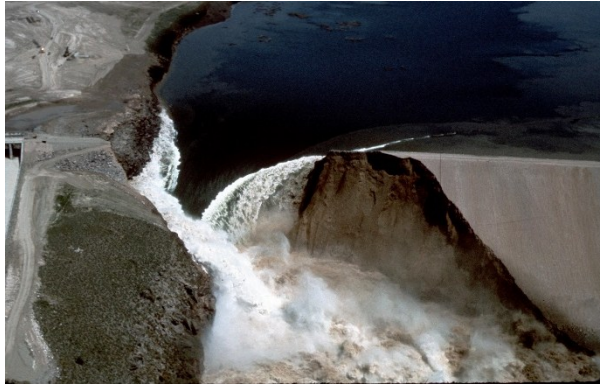
Figure 4: Teton Dam Failure

The failure was caused by a combination of poor foundation design and inadequate geological investigations. The dam was built on a foundation of highly permeable material, which allowed seepage to occur. Over time, this seepage eroded the dam's embankment, leading to its collapse

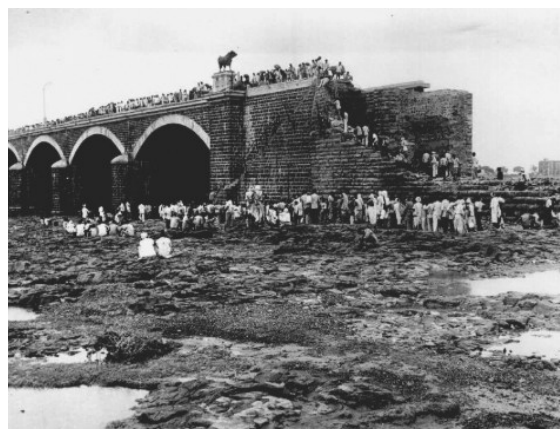
Machchu-2 Dam was built in 1959, having a catchment area of 730 square kilometres. On August 10, 1979, the Machchhu-2 Dam in Gujarat, India, failed after intense monsoon rains caused the dam to overflow. Inadequate spillway capacity and poor maintenance were identified as key factors contributing to the failure.

Figure 8: Machchuu-2 Dam Failure

The dam was unable to handle the excessive water load, leading to the breach of the embankment and flooding of nearby villages, resulting in approximately 1,000 deaths.

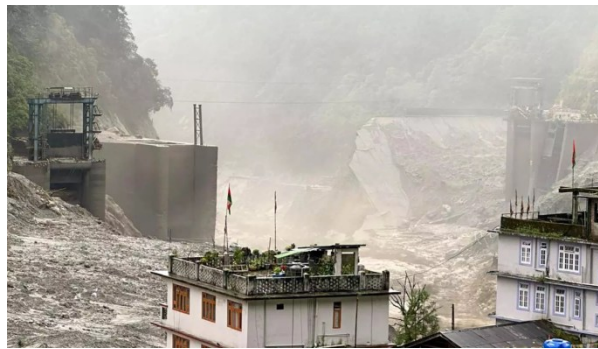
The construction of Teesta Dam was completed in 2013 located in Sikkim. In December 2019, the dam's upper reaches suffered structural damage, which led to the collapse of a portion of the dam's embankment. As a result, a massive amount of water was released downstream, leading to severe flooding in areas along the river. The disaster caused significant damage to infrastructure, property, and human lives affecting the state of Sikkim and the neighbouring regions.

Figure 9: Teesta Dam Failure

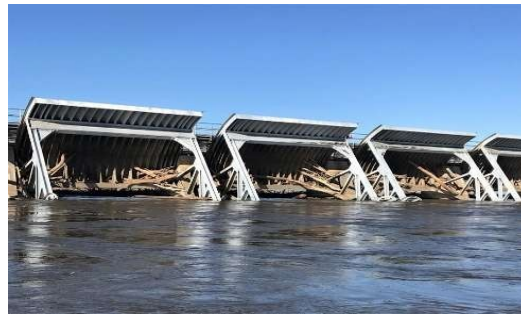
Figure 5: Debris stuck in dam gate

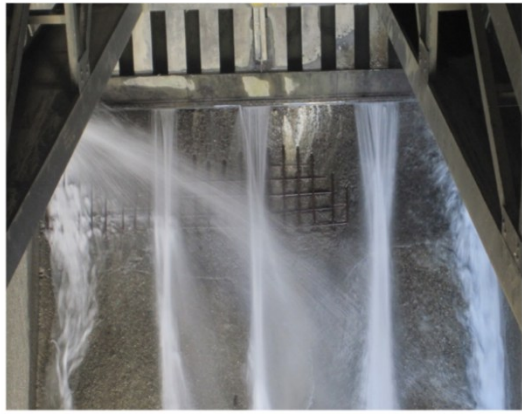
Erosion in Spillway Glacis

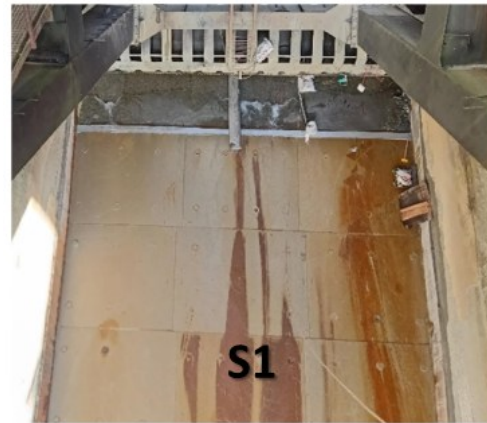
Restoration of Glacis with steel liner

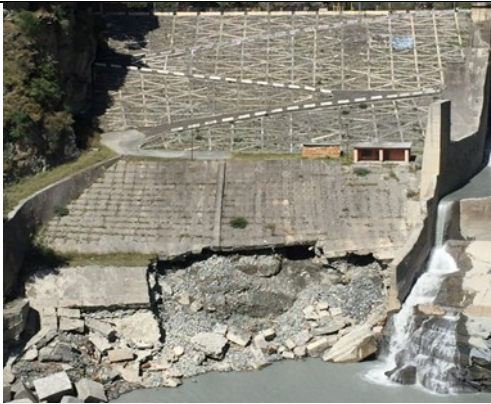
Erosion of D/s slope before repair

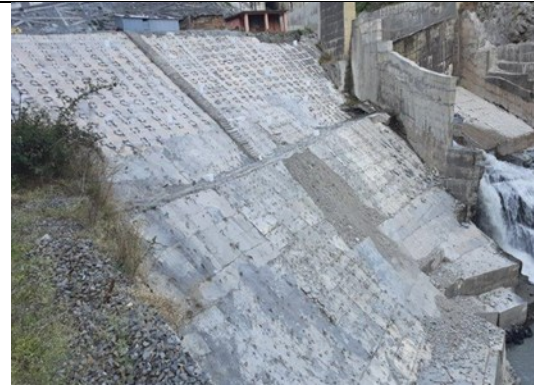
Restoration of D/s slope after repair
