International Conference **DAM SAFETY-2025**

Latest Technologies for Rehabilitation and Dam Safety

Workshop on

Grouting Technologies in Rehabilitation of Dams

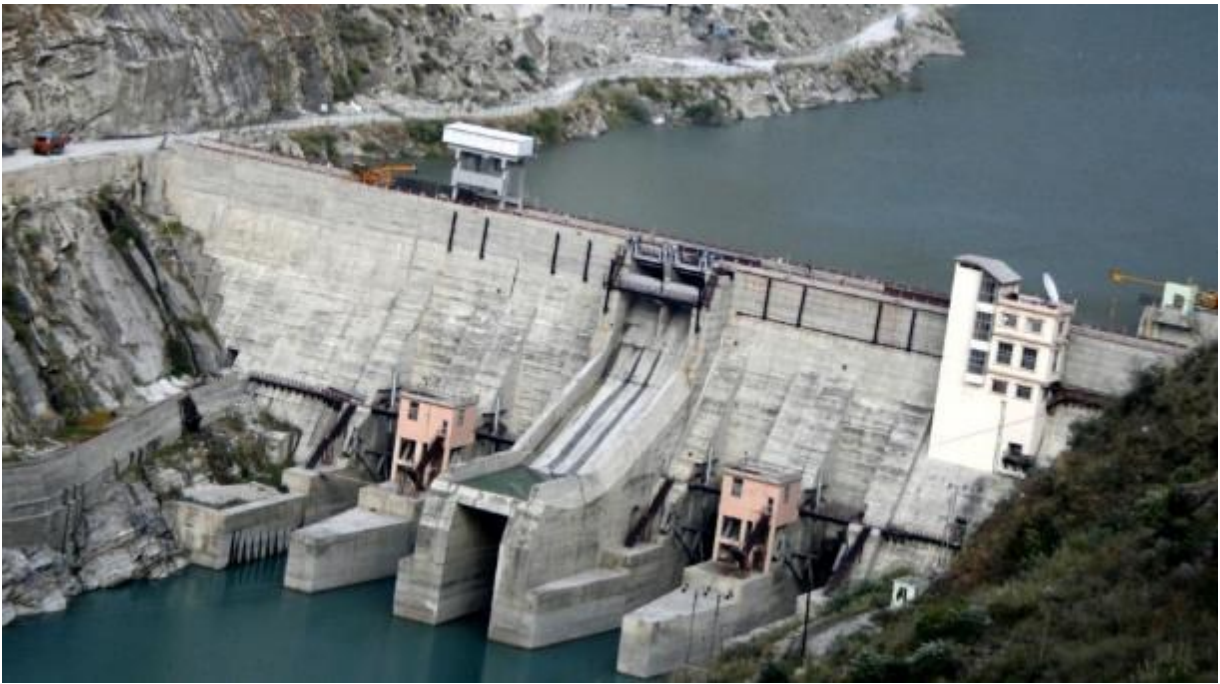
Figure 2. Downstream View of Nathpa Dam

boulders and high-velocity water discharge has been a critical issue for Nathpa Dam (Figure 2). Such damage, particularly in the sluice spillway of Nathpa Dam, has led to significant structural wear, as illustrated in Figure-3. If left unaddressed, abrasion processes can severely reduce the service life and safety performance of concrete structures.

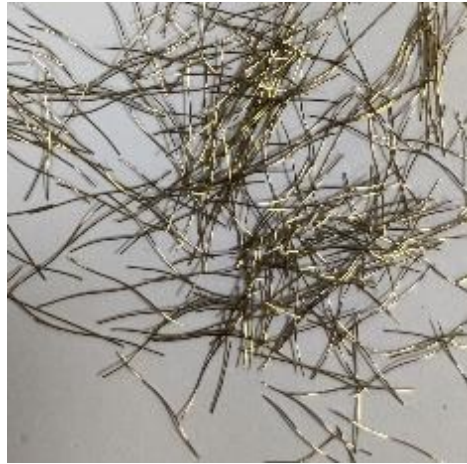
mm (length) were used in the present investigation, as shown in Figure 4. The micro-steel fibers were used in the optimized range of 1.5% by volume of concrete. The dosage of chemical admixture was kept in the range of 0.5 to 1.5% by volume of concrete to achieve the desired workability.

Figure 4. Steel fiber used in the present study.

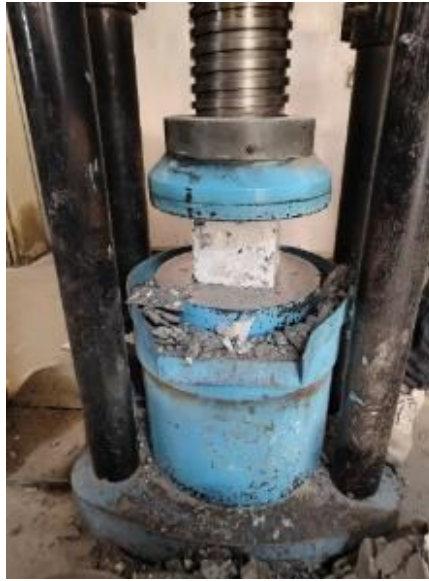
Where, f_c is compressive strength in MPa or N/mm², P is maximum load in N and A is cross sectional area of cube in mm².

Figure 6. Testing and failure of 150 mm cube specimen.

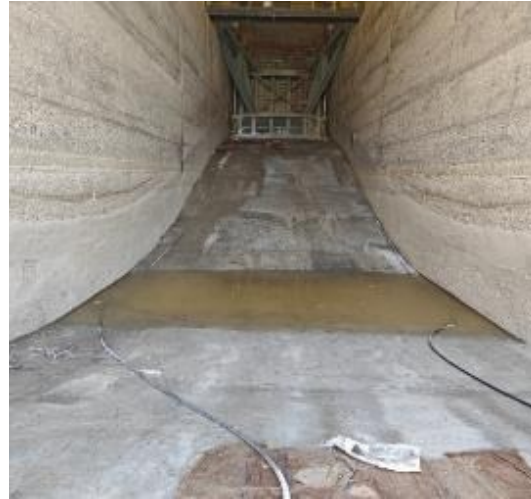
Figure 10. Repaired sluice spillway at Radial Gate No. 3.

bottom for section (II) and vice versa for section (III) and (IV). This was chosen as per the site requirement and inclined profile of the sluice spillway. M80 grade concrete was used in section (I) between the rails. The repaired sluice spillway at the Radial Gate No. 3 is shown in the Figure-10.

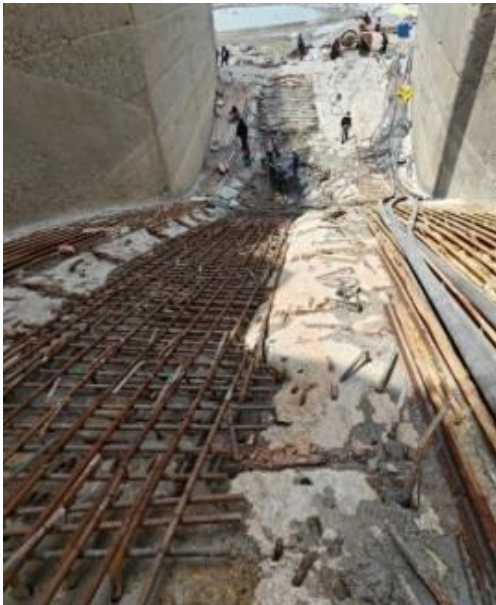
Figure 11. Surface preparation and laying of reinforcement of sluice spillway at Radial Gate No. 4.

The repair process adopted for the sluice spillway of Radial Gate No. 4 is discussed now in the following section. The surface was thoroughly cleaned and new longitudinal and transverse was placed as shown in the Figure11. In this spillway, major damage was observed in the flip bucket of nearly 1m depth due to higher impact of boulder. The longitudinal reinforcement was embedded and crossed inside the flip bucket for better connection and bond with the parent concrete. The flip bucket was filled with M80 grade of concrete till the level of old parent concrete. Moreover, cavities adjacent to the existing reinforced were repaired using the epoxy grouting for better bond. The overall repair was done using M80 grade of concrete in sluice spillway Radial Gate No. 4.

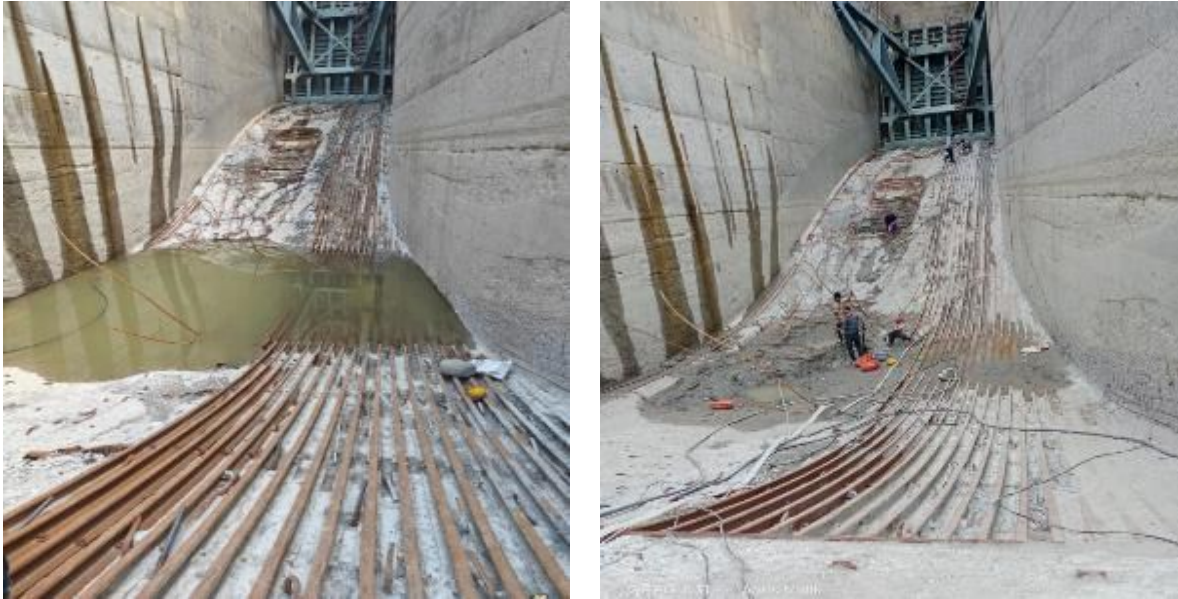
Figure 12. Sluice spillway at Radial Gate No. 5.

The sluice spillway at Radial Gate No. 5 was repaired using the combination of M80 and M80S and rails were mounted over the top layer to reduce the abrasion and impact loss due to the fast-moving boulders. The condition of sluice spillway at Radial Gate No. 5 prior to the repair is shown in Figure 12. It was found

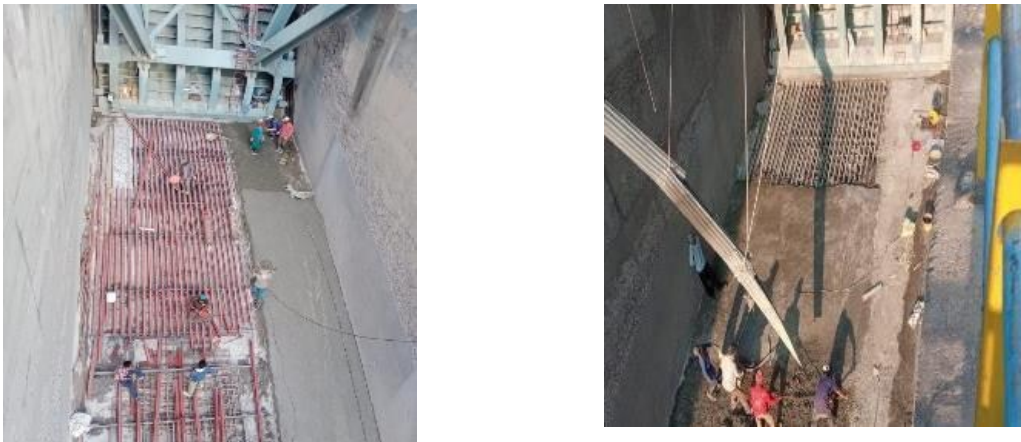
Figure 13. Placement of M80S grade concrete on the right side of the existing rails.

After this M80S concrete was placed in between the existing rails. The longitudinal and transverse reinforcement was placed as per the drawing and the new rails as visible on the left side as shown in Figure 13 were placed and these rails channels were welded with the existing anchors connected to the parent reinforcement. The M80 grade concrete was placed in this section of new rails till the flip bucket of sluice spillway of Radial Gate No. 5. The downstream portion adjacent to the flip bucket was completely repaired using M80S grade of concrete.

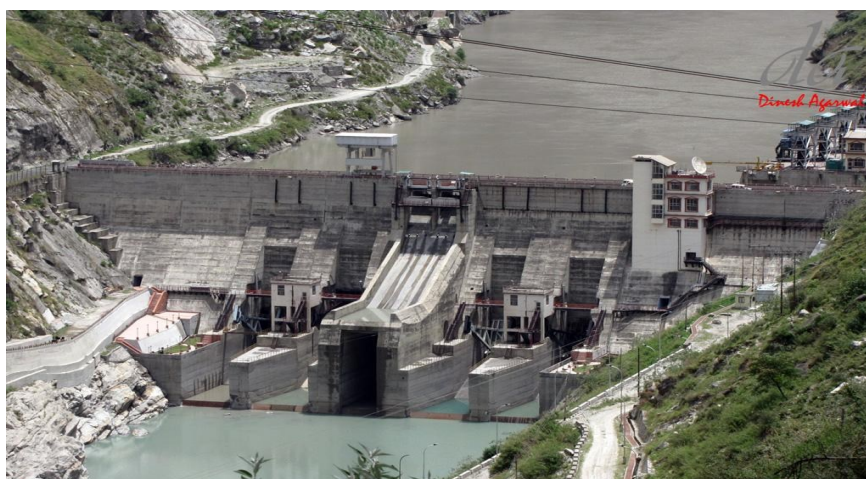
Figure 2. Downstream View of Nathpa Dam

Nathpa Dam is the backbone of both the Nathpa Jhakri Hydropower Project (NJHPS) and the Rampur Hydropower Project (RHPS), playing a crucial role in their successful operation. As the primary water diversion structure on the Satluj River, it regulates and feeds water into NJHPS, which generates 1,500 MW of power through its underground powerhouse at Jhakri. Additionally, RHPS, a tailrace development of NJHPS, utilizing the 383.88 cumecs of design discharge of NJHPS to generate an additional 412 MW. By maintaining hydrological stability, Nathpa Dam enables both projects to function in tandem, maximizing energy production while ensuring efficient resource utilization without requiring a separate dam for RHPS. Therefore, the safety inspection of Nathpa dam is essential for maintaining its structural integrity and operational reliability to run both the projects successfully. Designed as Concrete Gravity of 62.5 m height, are total of five sluice spillway and an overhead spillway in the dam to regulate the excess water flow. The downstream and upstream view of dam is shown in Figure 2. & Figure 3.

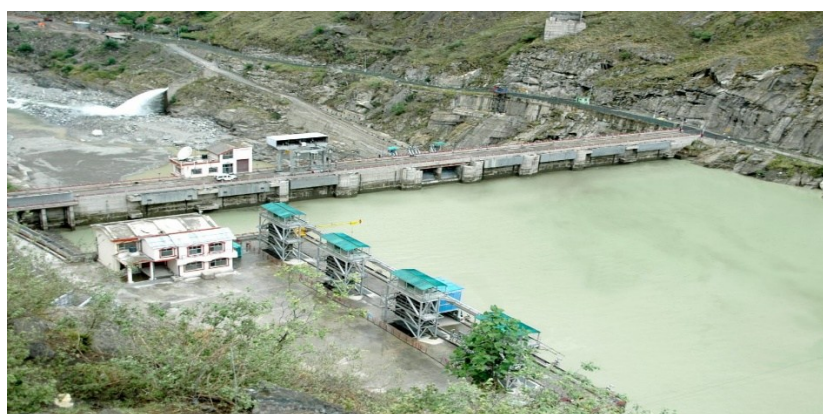
Figure 3. Upstream View of Nathpa Dam

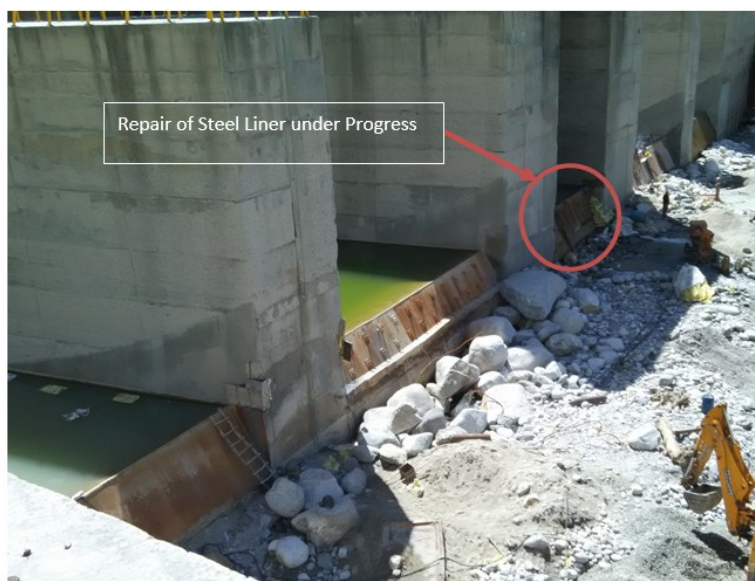
Figure 4. Steel liner at the end of roller bucket

Conditions of surface of sluice spillways and their roller bucket are also checked and any repair required is recommended. Also ongoing activities are also recorded for example repair of roller bucket etc. (Figure 4). Exposed rock slopes on the left side of the dam and right side of dam are also observed. Requirement of any shotcrete or any slope stability measures if required are recommended. The stilling basin is also observed from sediment accumulation point of view. Repair of downstream area downstream of stilling basin is also observed.

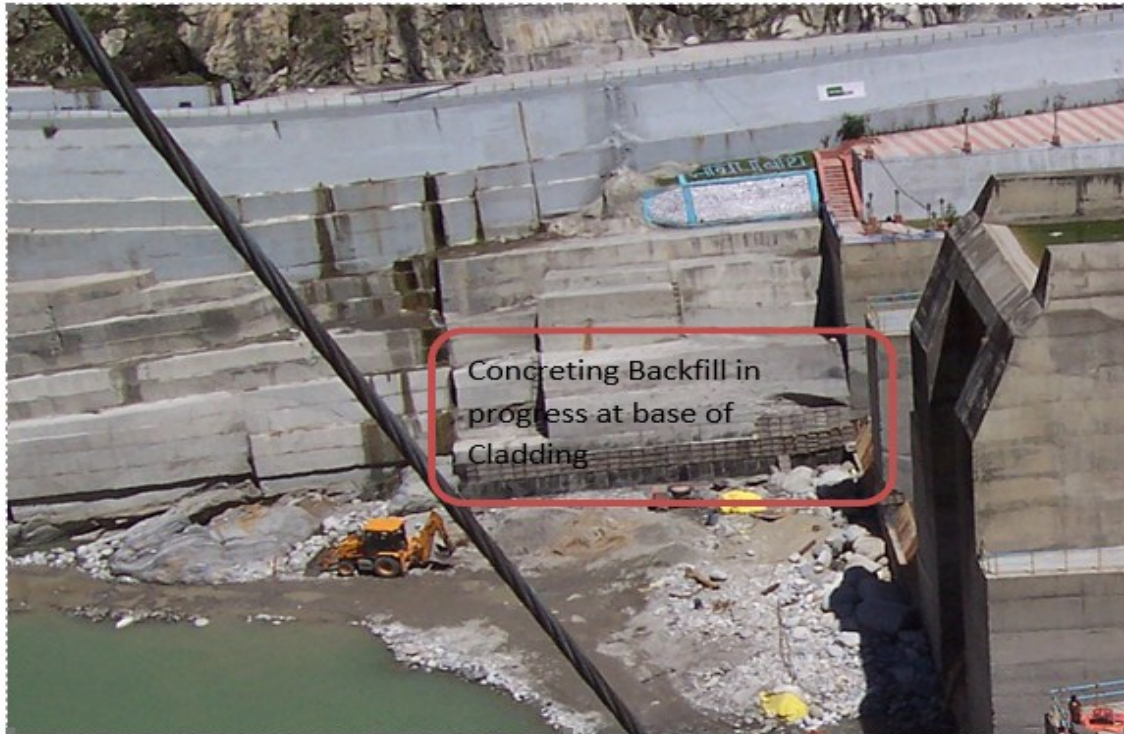
Figure 5. Concreting Backfill in progress at base of Cladding.

After the inspection, preventive maintenance measures are recommended before the monsoon season. Key recommendations include replacing rusted V-notches, monitoring seepage levels, completing sluice and spillway repairs, restoring non-functional instrumentation, and shotcreting of exposed loose rock areas. An example of repairing the downstream slope is shown in Figure 5.

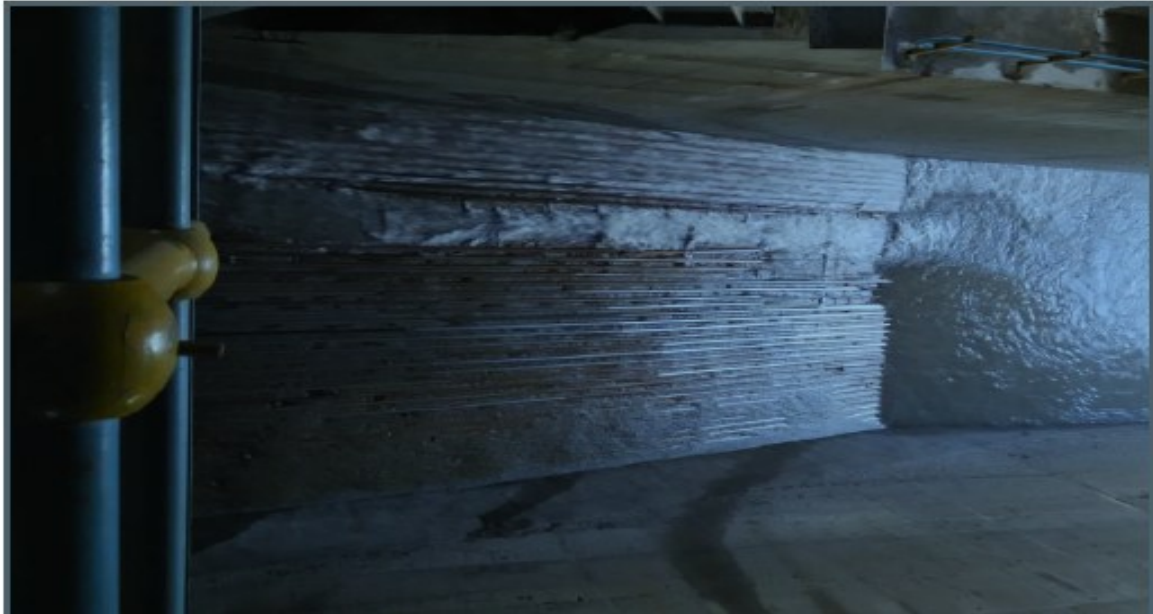
Figure 6. Damaged floor of under sluice

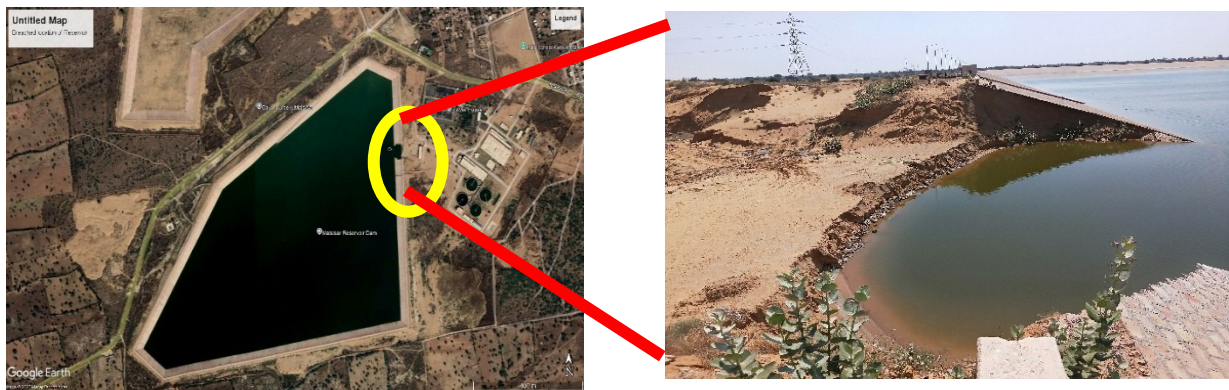
Figure 1. Location and details of Earthen Dam Failure

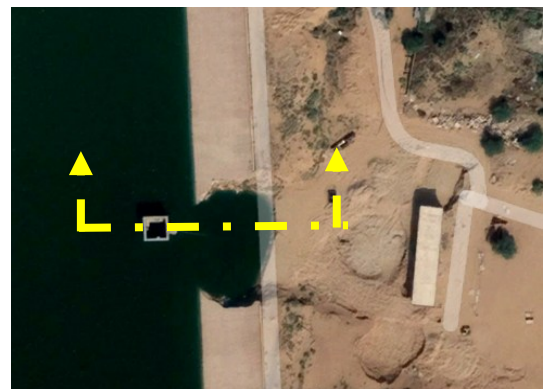
Figure 2. Breach Cross-section

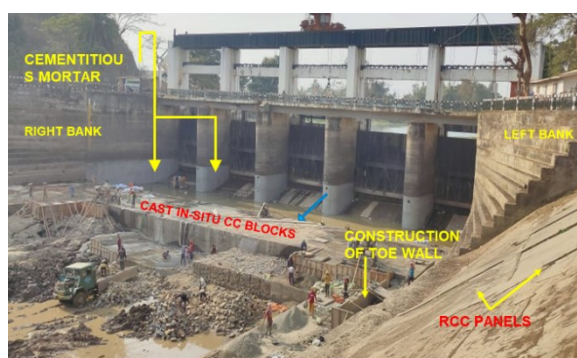
Figure-3:- Ongoing repair work in stilling basin

- Erosion damages on the surface of piers, abutments, gate grooves & bridge to be repaired with cementitious mortar conforming to EN1504-3-R4.
- Glacis /stilling basin damages to be repaired with HPC (M60/A20 grade).
- Underwater inspection to be carried out & repair of components of stoplog arrangements, apron, piers, gate grooves & abutments with epoxy mortar.
- To prevent frequent under-scouring & damages of the downstream left-wing wall, it is proposed to replace it with new structure comprising of toe wall & RCC panels. Further, cast-in-situ concrete blocks (2.5x2.5x1.25m) in a stretch of about 15m throughout the width of the river along with boulder wire crates proposed to be provided along the entire length of toe as additional safety measures.
- To facilitate centralized operation of barrage gates, it is proposed to construct a prefabricated control room.

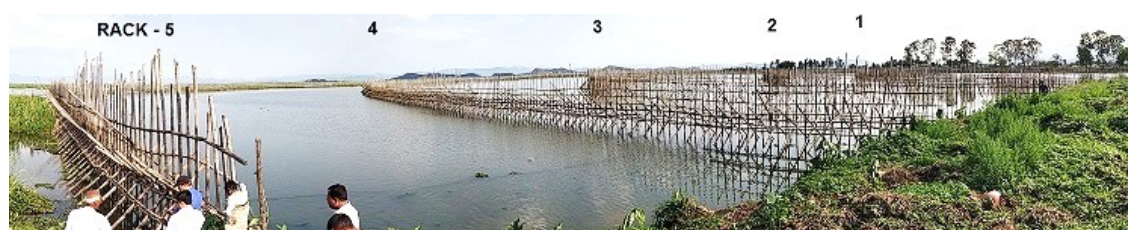
The Loktak Lake is observed to be infested with phumdis/ aquatic weeds. To restrict the entry of phumdis in to the power channel, 5 rows of bamboo trash rack of varying length (200-1000m) have been provided. Damaged bamboo trash racks were replaced/ repaired

Figure-5: View of the Bamboo trash rack at Power channel

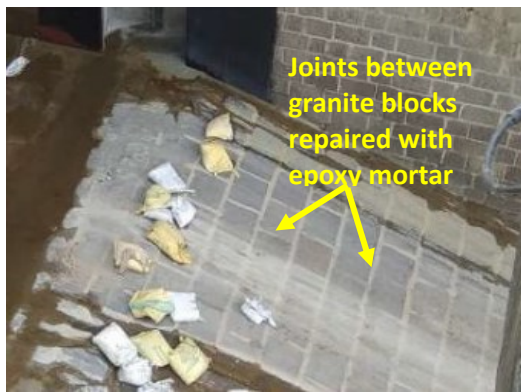
Figure 3. Repair done in spillway glacis

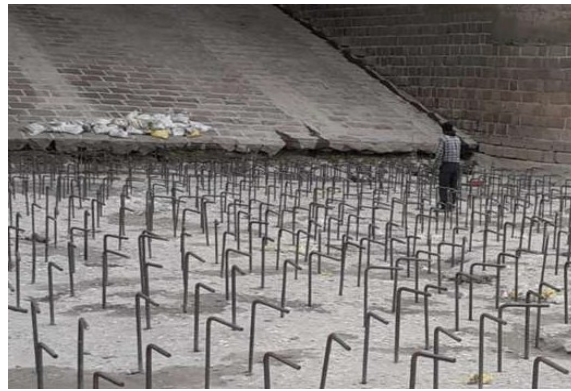
Figure 4. Ongoing repair work in stilling basin area

Repairs with HPC involve a 500mm wearing layer over the base concrete, anchored with 25mm Fe500 steel bars (1200mm long) fixed with epoxy grout at 1m spacing. Anchors penetrate 500mm into old concrete, bent 90° downstream, with a 50-200mm clearance. The epoxy grout has a 10 MPa bond strength (ASTM C882). HPC repairs have proven effective, extending maintenance intervals to 7-10 years.

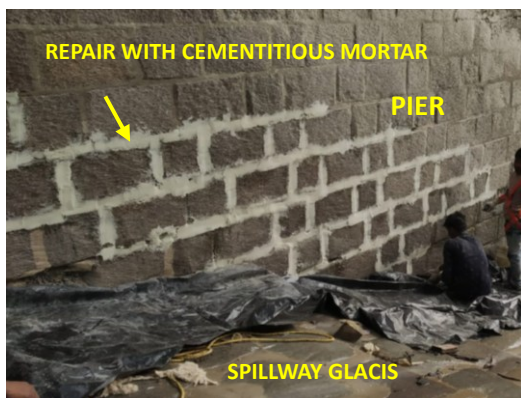
Figure 5. Repair work in Spillway pier

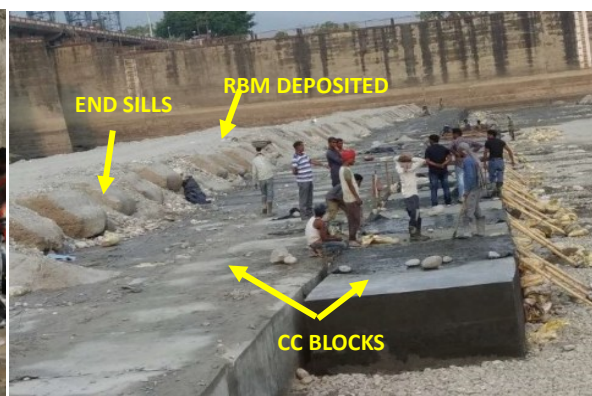
Figure 6. Repair of Launching apron with CC blocks

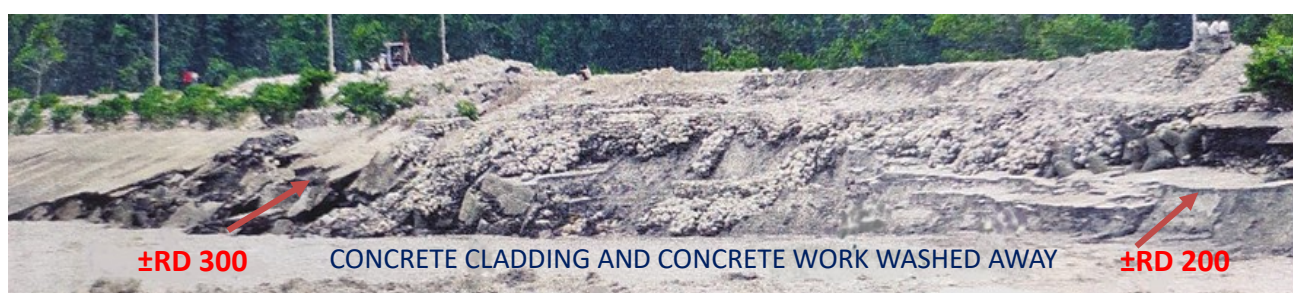
Figure 3. View of damages in Left afflux bund after monsoon 2013 flood

Guide cum afflux bunds at Tanakpur Barrage, extending ~2200m on the left and ~2188m on the right, are compacted riverbed material with a 2.5H:1V slope. Tied to high ground in Nepal (left) and Sharda Ghat (right), these bunds have experienced scouring due to siltation-induced flow channel shifts, with velocities reaching 6m/s. Damage assessments led to strengthening with PP rope gabions, hexagonal wire mesh gabions, and tetrapods, significantly reducing damage frequency. This standardized repair approach aligns with CWC's 2018 "Manual for Rehabilitation of Large Dams."

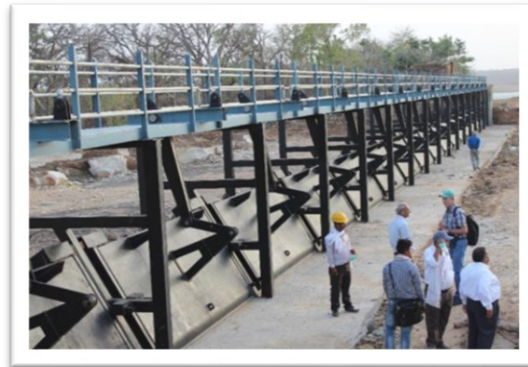
Automatic Godbole Gates at Chandpatha dam, MPWRD

Chandpatha Dam, located in Madhya Pradesh and owned by the Madhya Pradesh Water Resources Department (MPWRD), is over 100 years old. Originally, the dam used an ungated weir for floodwater release. However, with the revision of the design flood, the existing infrastructure needed to be upgraded.

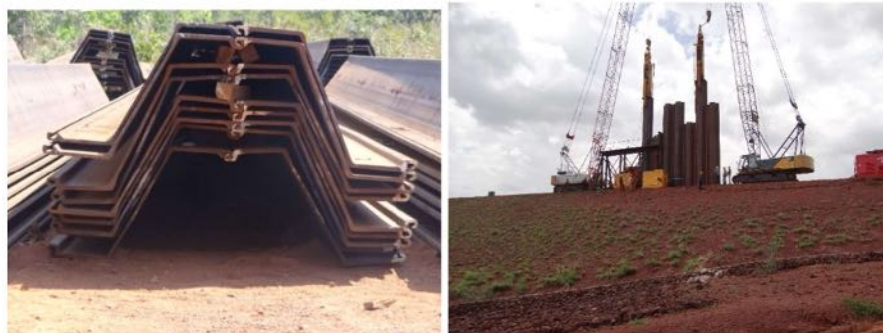
SP were paired by crimping in the factory (Photo 1) to provide high buckling resistance. Installation was conducted using heavy impact hammers. Vibratory hammers were abandoned because they could not drive SP through the embankment, confirming its good compactness.

Photo 1. Paired sheet piles delivered on the jobsite (left), driving on the dam crest (right)

To prevent deflection of the SP, these were set on a frame of almost 3m height, anchored on the crest. Each pair of sheet was installed inside the frame, plumbed and secured before setting the next pair. Driving started when a whole panel was set, respecting an increment smaller than 2m within the panel. Interlocking joints were filled with a special sealing product aiming at providing the required water tightness.

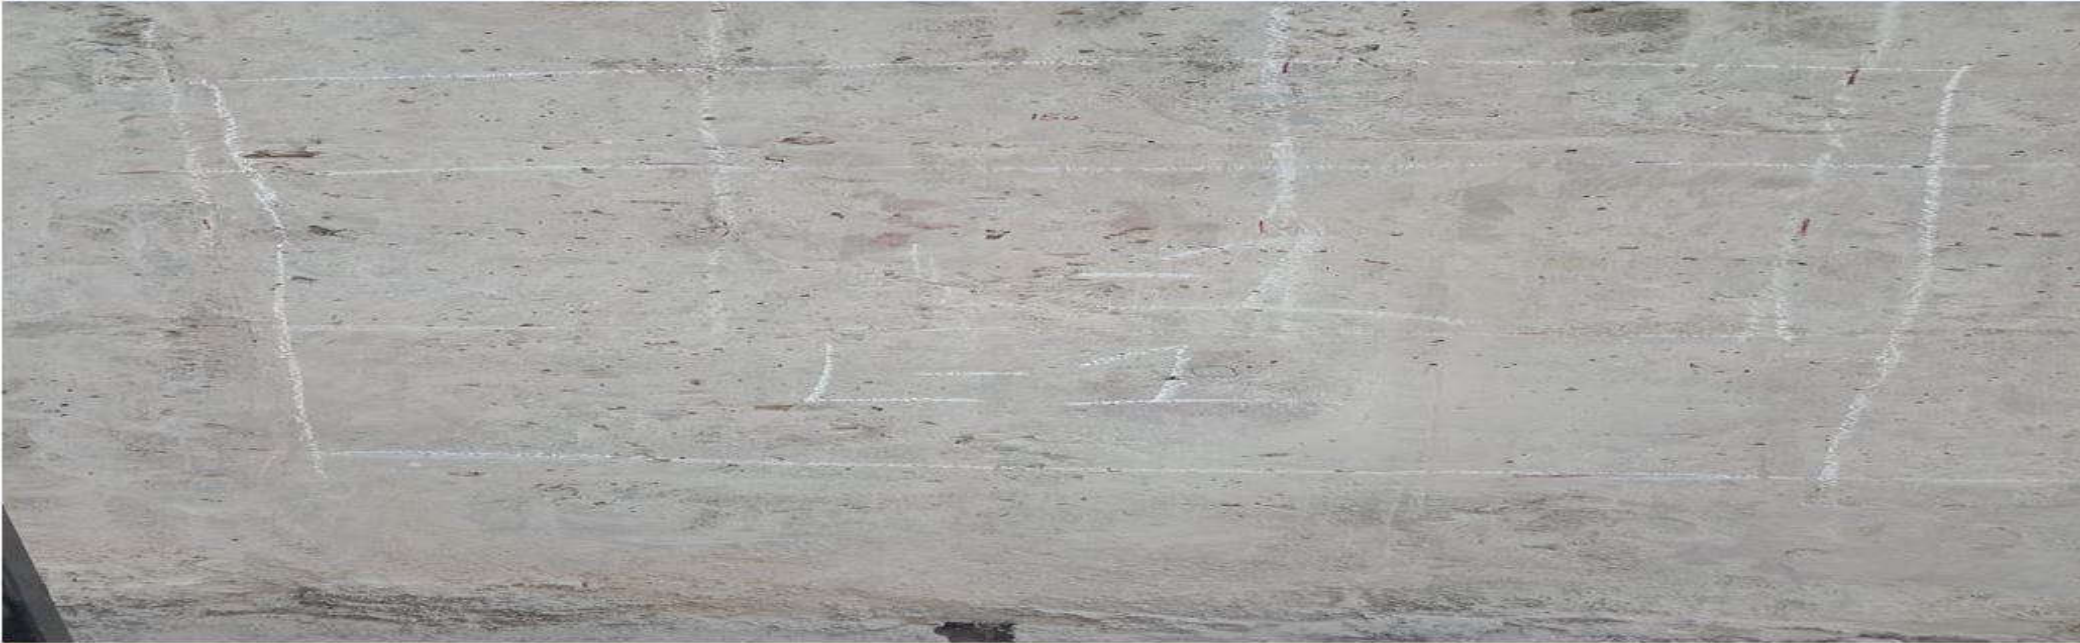
LOCATION			D/S- FRONT <u>FACE/L-1@3.61</u> Ht.		
GRID			3 x 3

RANGE OF DISTRESS			LEGENDS		
			No or Very Minor Voids/Honeycombing		
			Minor Voids/Honeycombing		
			Severe Honeycombing

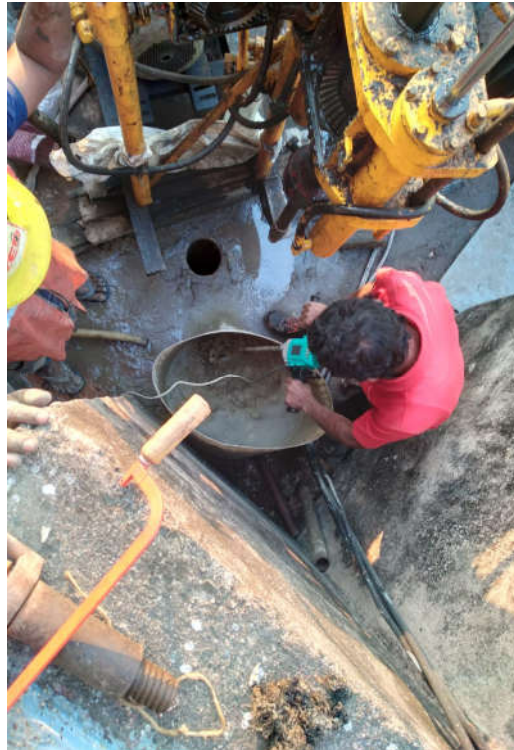
PACKET PERMEABILITY TEST

- DIAMETER OF BOREHOLE
- LIFT JOINTS
- HIGH PRESSURE

Sr. No.	Stream	Test Section (m)	Lugeon Value	Group	Classification	Remarks
1	U/S	1.50 – 4.50	0.736	D	Washout	
2	U/S	4.50 – 7.50	0.00	C	Dilation	
3	U/S	7.50 – 10.50	15.337	B	Turbulent Flow	There is possibility of leakage
4	D/S	0.0 - 3.0	0.00	C	Dilation	
5	D/S	3.0 - 6.0	0.00	C	Dilation

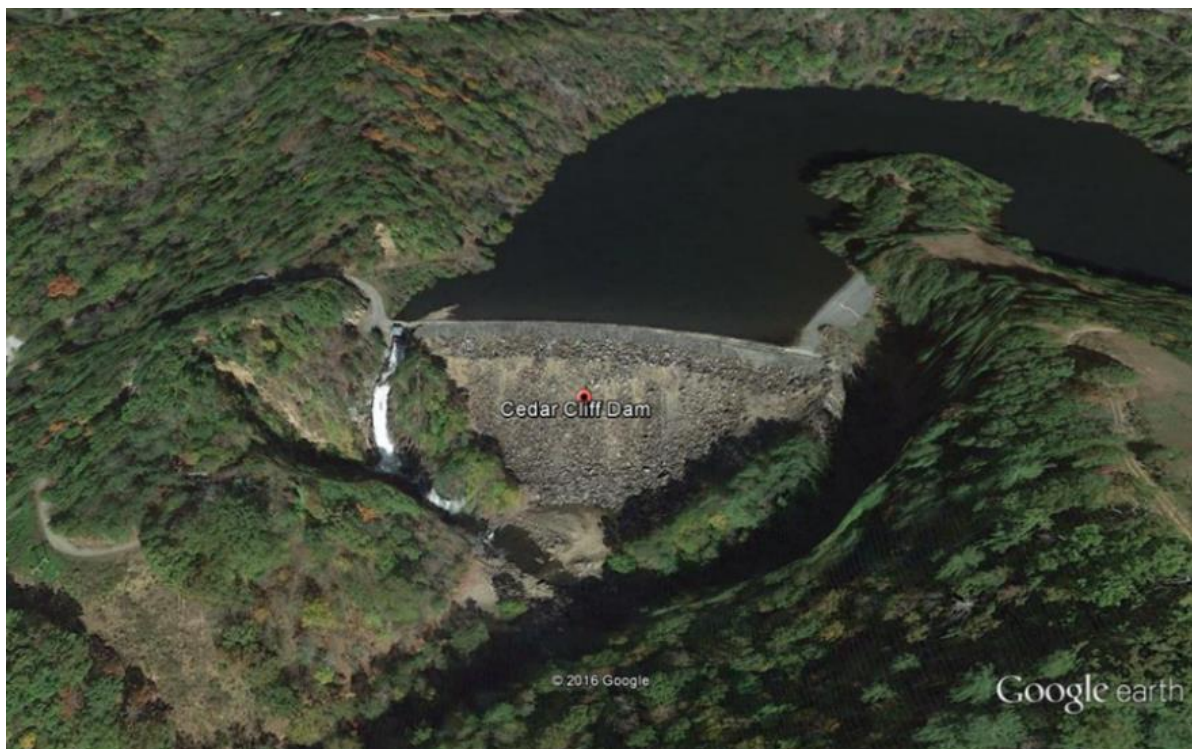
Figure 1 Satellite view of Cedar Cliff dam

The dam is a rock-fill embankment with a sloping compacted earth core, a length of 179.83 m (590 ft) and a maximum height of 52.73 m (173 ft). The embankment has a nominal downstream slope of 1.3:1 (H:V) and a variable upstream slope of 1.3:1 (H:V) that flattens toward 2.2:1 (H:V) for the lower two-thirds of the structure height. The dam crest is 7.62 m (25 ft) wide and includes a concrete parapet wall along its entire length that varies in height from 0.45 m (1.5 ft) to 1.13 m (3.7 ft). The nominal crest elevation along the parapet wall is El.714.30 m (El.2,343.5 ft) msl. An overall view of the dam and its two spillways are shown in Figure 1.

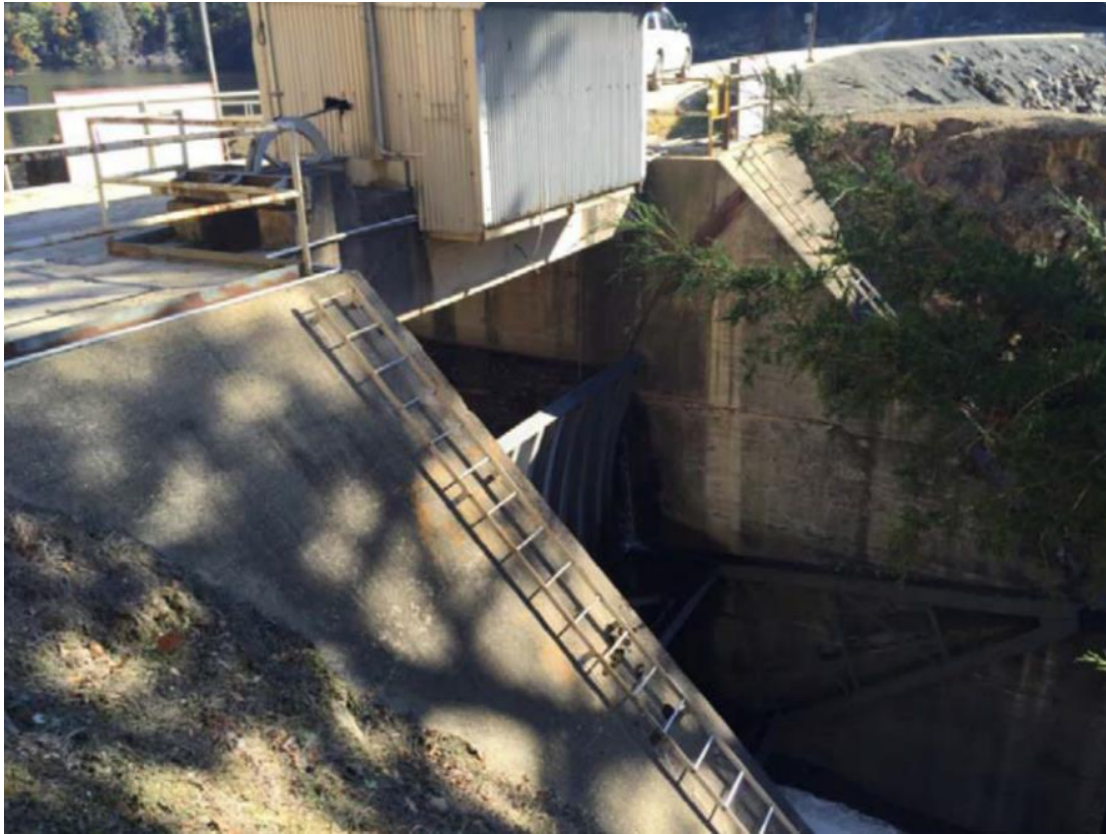
Figure 2 Main Spillway

The existing spillways at the dam include a principal spillway (Figure 2) with one Tainter gate at the right abutment (when looking downstream) and an auxiliary spillway (Figure 3) with two erodible fuse plugs at the left abutment. The principal spillway Tainter gate is 7.62 m (25 ft) wide by 7.62 m (25ft) high with a sill elevation of El.702.56 m (El.2,305 ft) msl and is supported by concrete sidewalls doweled into rock. The principal spillway is a rock cut channel that conveys water to the bypassed East Fork of the Tuckasegee River located near the downstream toe of the dam.

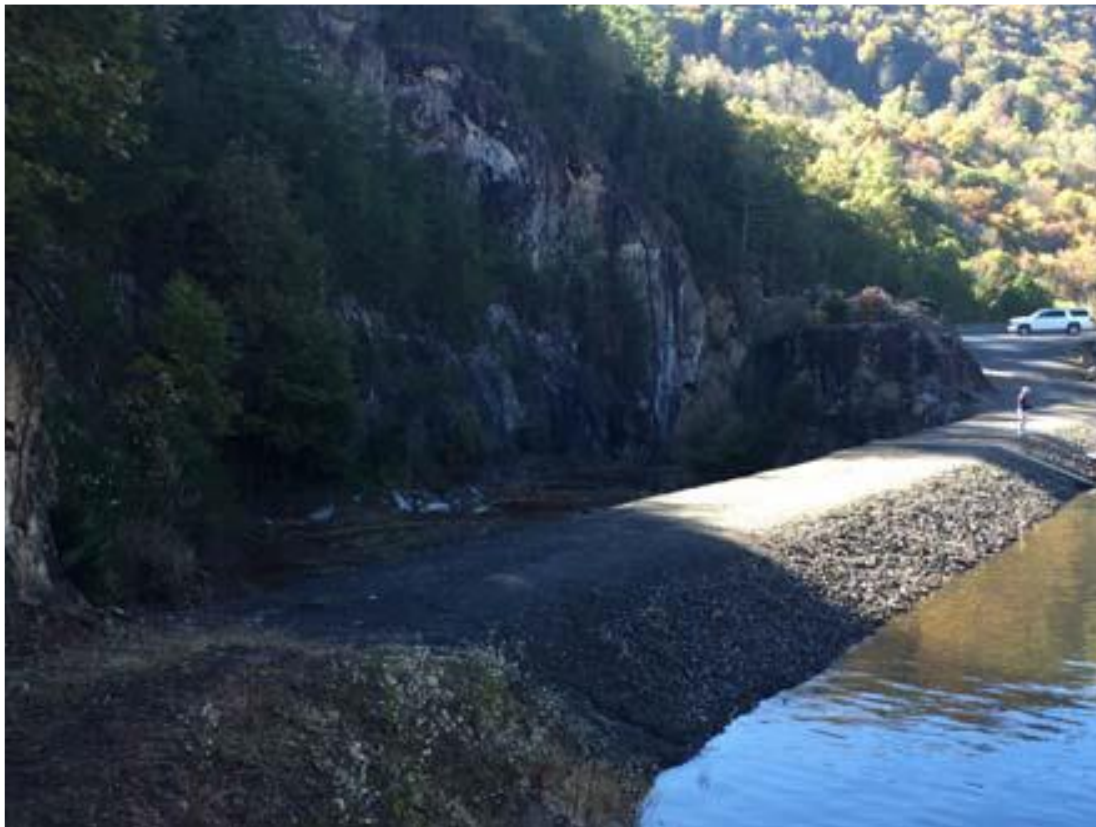
Figure 3 Auxiliary spillway with fuse plug

Activation of the fuse plugs and conveyance of water through the auxiliary spillway channel for flood operation purposes is attributed to overtopping of the erodible fuse plugs.

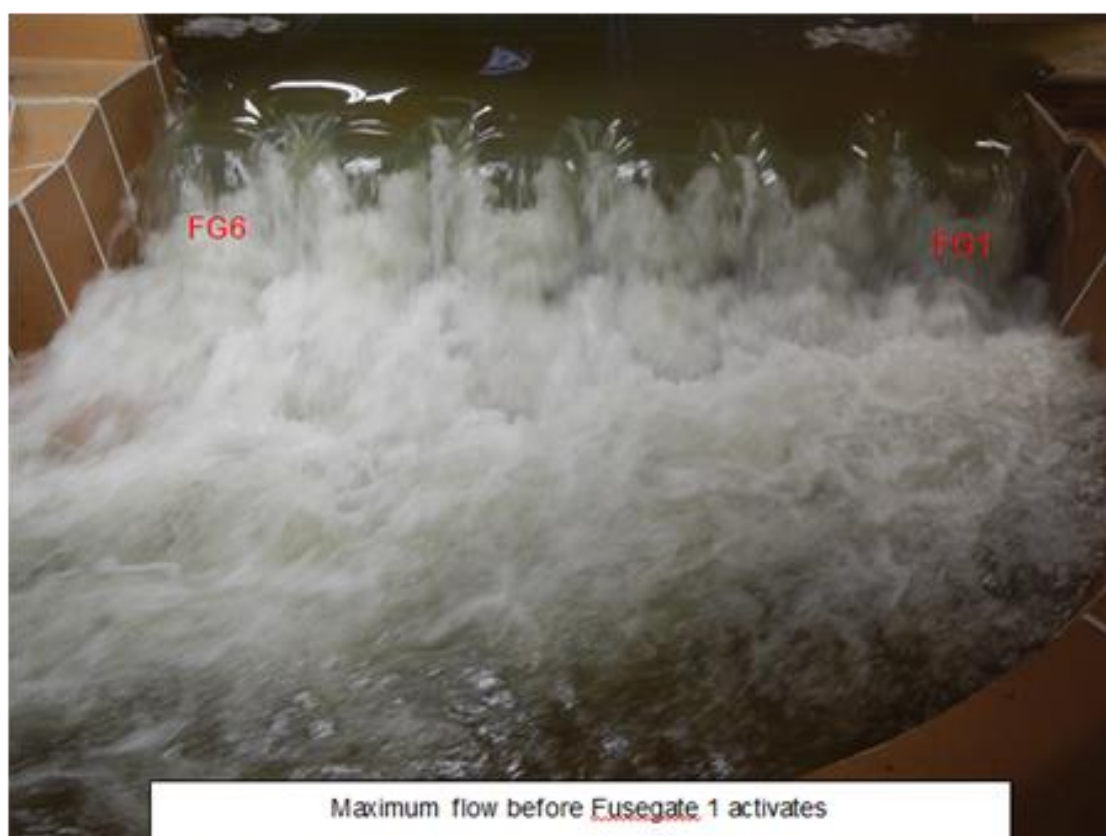
Figure 10 1,254 cms, nominal pool elevation of 713.38 m

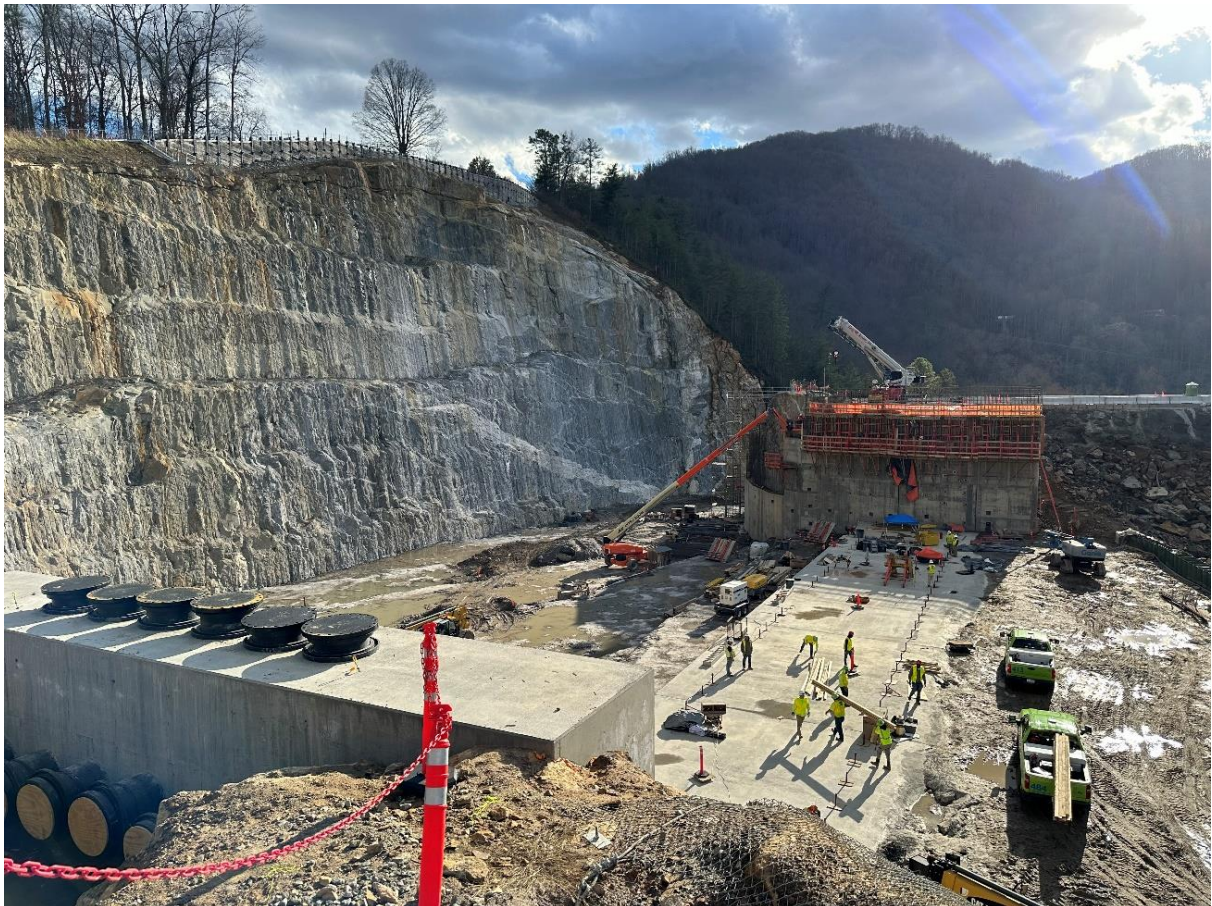
Figure 13 Overview of the spillway sill during the initial survey

The survey crew established the Fusegate layout on the sill concrete based on the IFC (issued for construction) drawings. Local control points were established for layout and elevation verification during the construction process. Fusegate layout was established using the existing project control points.

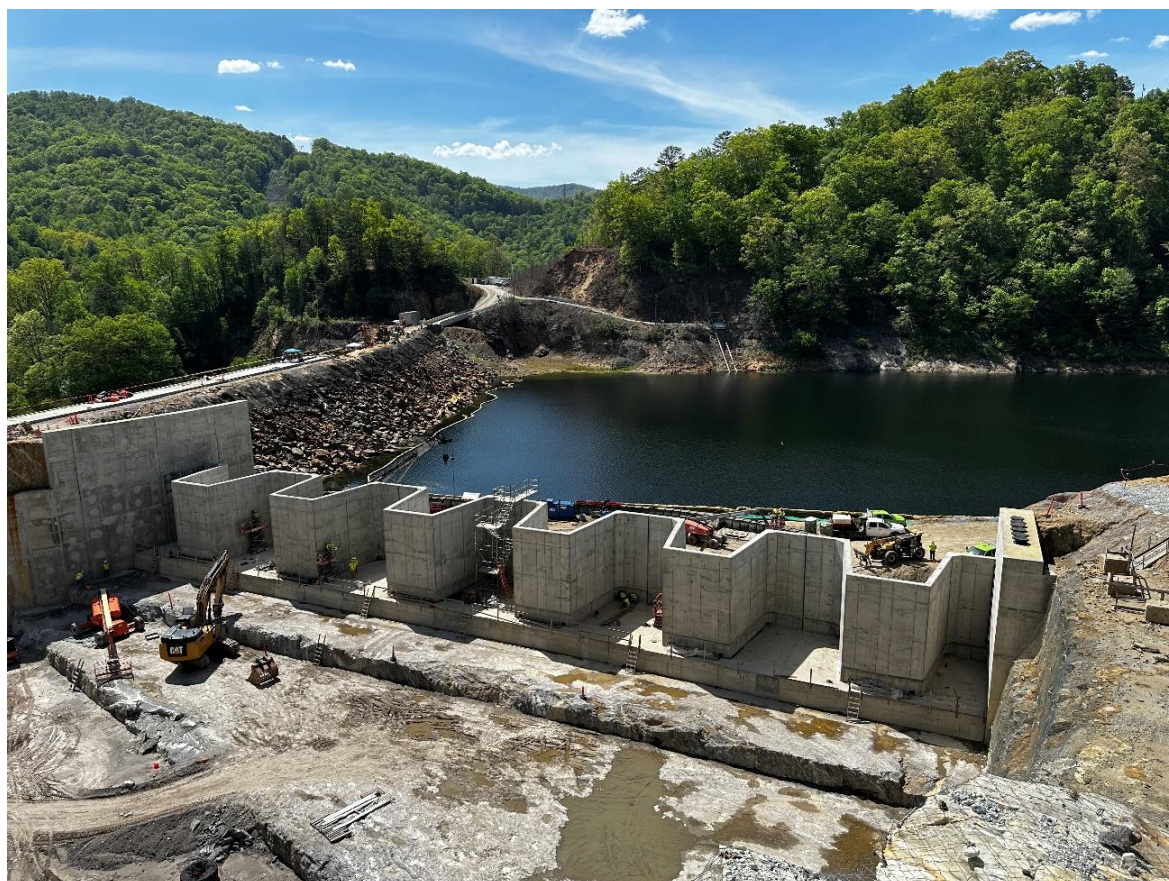
Figure 14 Fusegates downstream view after completion (during the as built survey)

Installation of the watertightness system was performed after the completion of the ballast for each Fusegate. The watertightness system consists of steel plates and EPDM seals installed between each Fusegate, vertically and between the Fusegates and the spillway sill horizontally. It ensures watertightness of the Fusegate system.

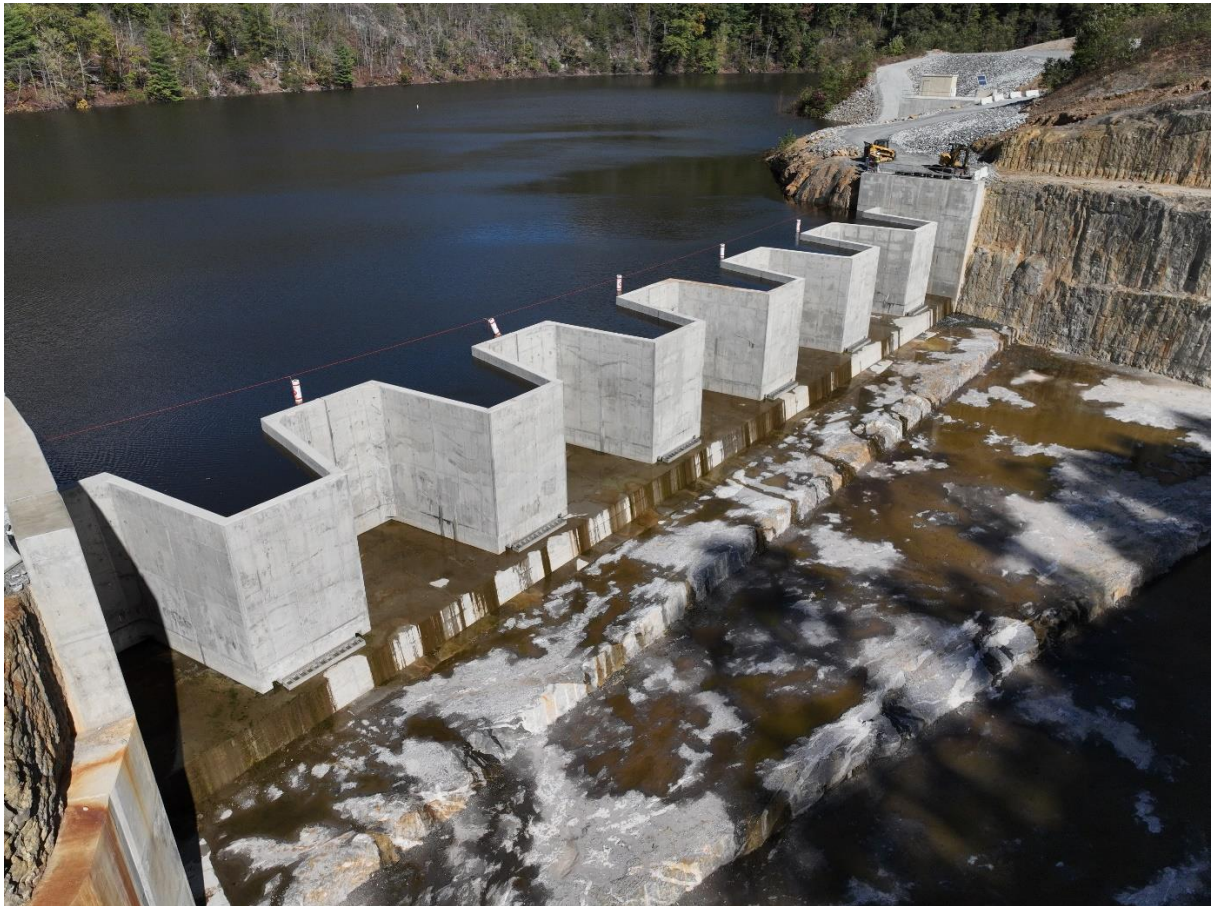
Figure 15 Fusegates downstream view in operation

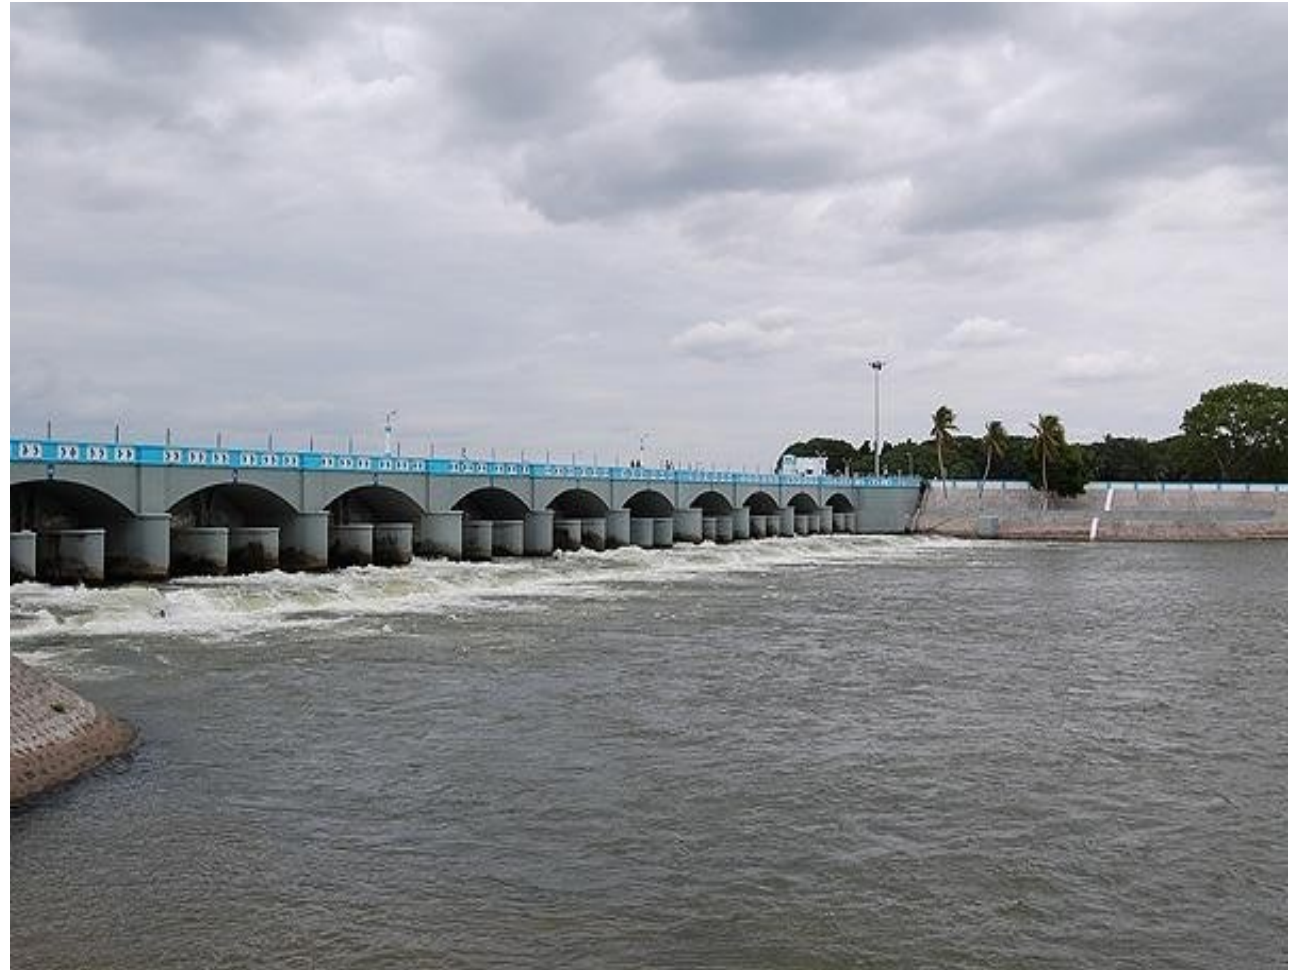
- India has a long history of water management systems for efficient water storage and distribution, including traditional step wells, tanks, as well as construction of dams and canals.
- The Chola dynasty is renowned for its contributions to dam construction. The Kallanai Dam built on Kaveri River in Tamil Nadu during 1st Century AD is considered one of the oldest functional dams in the world.
- The Kallanai dam is a massive structure constructed with uneven stones to a length of 329 m and a width of 20 m across the mainstream of the river.

Grand Anicut (Kallanai Dam), 1st Century AD

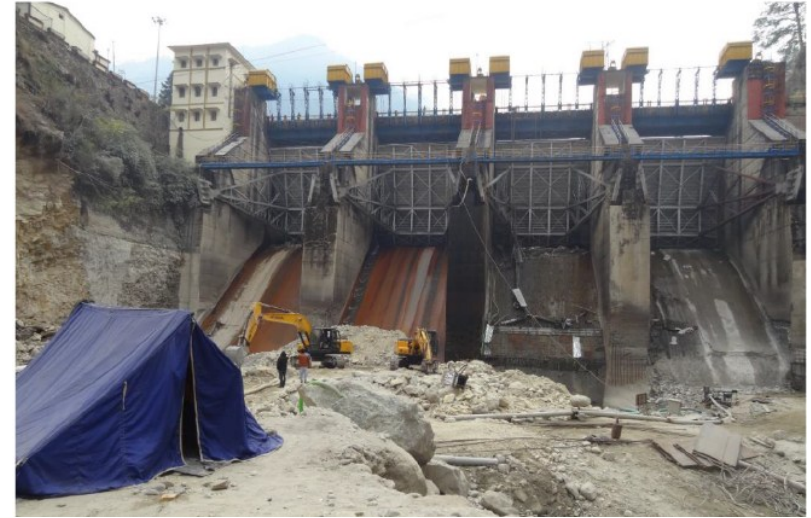
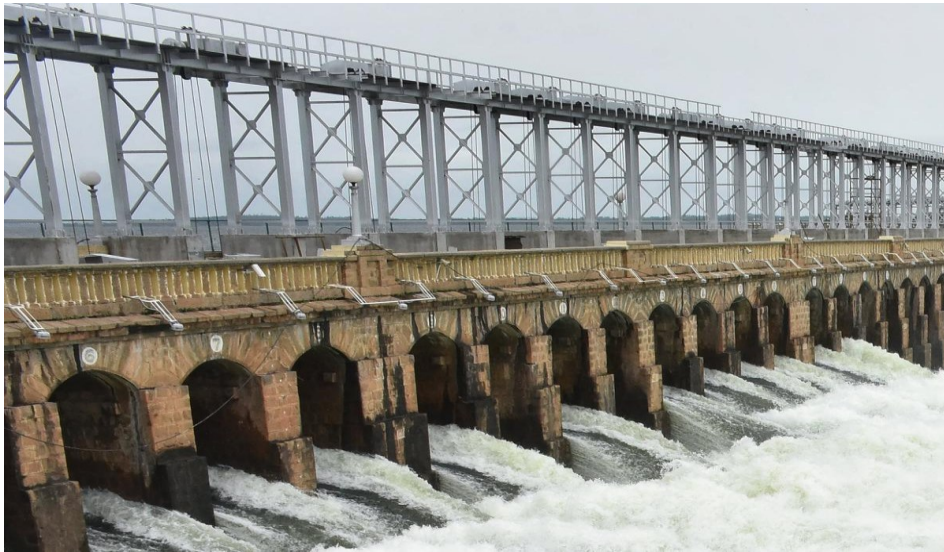
Hydraulic Safety at Maneri Dam

Repair of spillway glacis and energy dissipater with M90 concrete (Maneri Dam, UJVNL)
