International Conference **DAM SAFETY-2025**

Latest Technologies for Rehabilitation and Dam Safety

Workshop on

Grouting Technologies in Rehabilitation of Dams

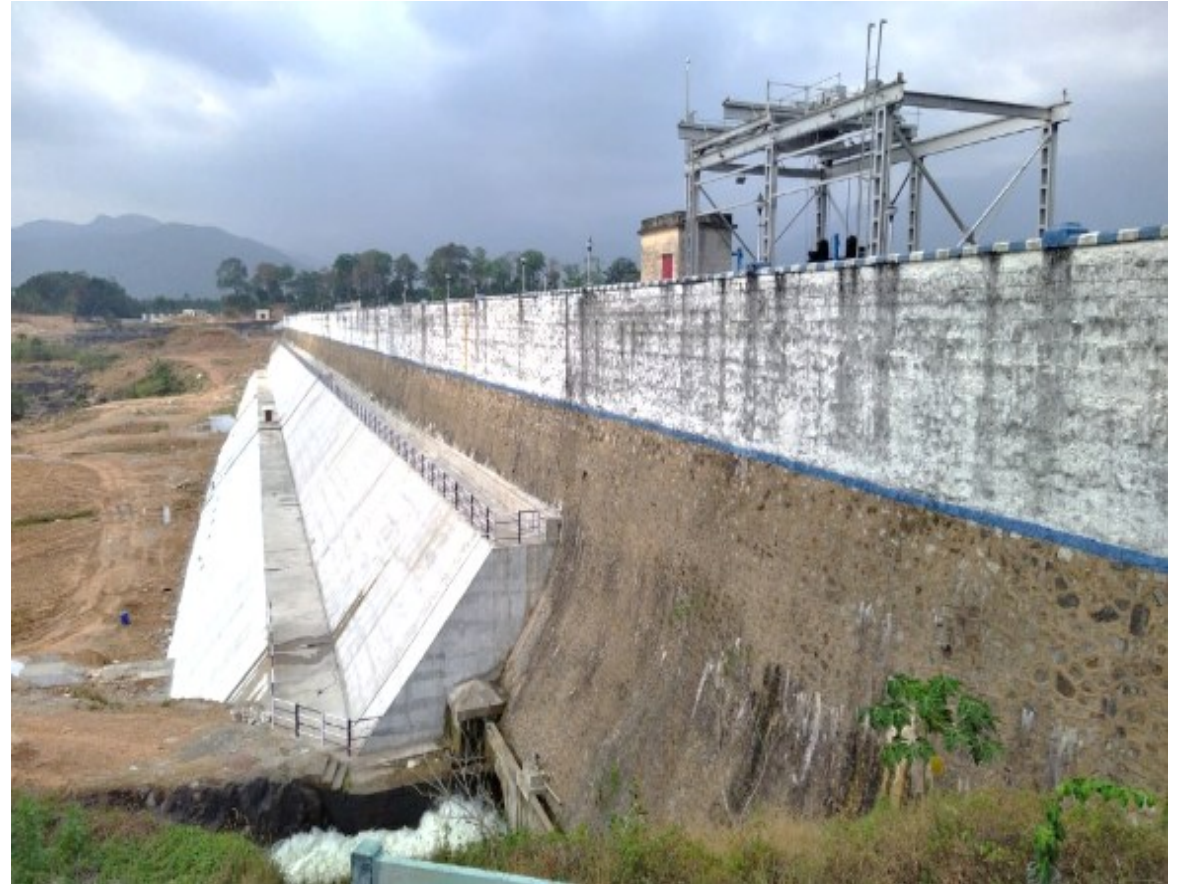
Pechiperai Dam, Tamil Nadu

- Seismic Zone - III
- The existing dam was found unsafe under seismic loading
 - ✓ Backing Concrete

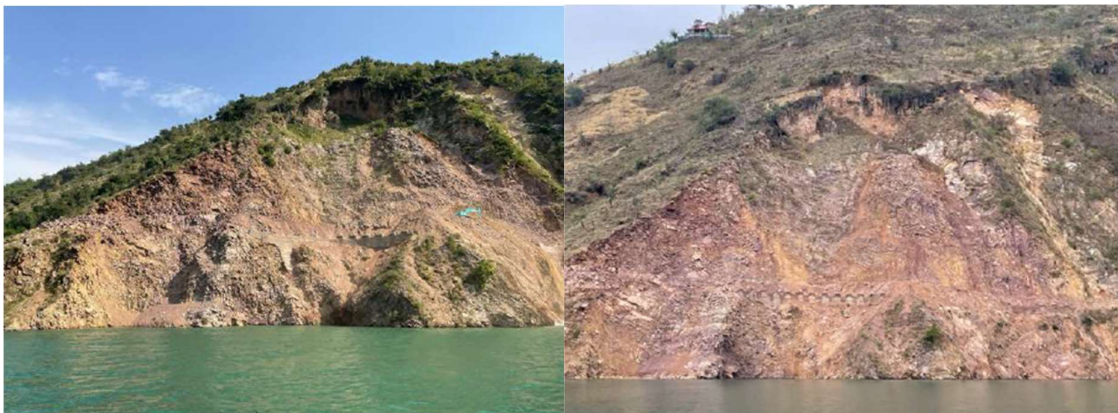
Figure 7: Comparison of same slide in pre and post monsoon reservoir rim inspections

Reservoir Rim Inspection: Entire reservoir rim of about 40 km length is inspected by a cross-functional team, in pre monsoon and post monsoon seasons. Different deformation and landslides along the reservoir rim are recorded. The pre and post monsoon condition of individual slide is compared. A comparison of movement and condition of slides in previous years is also done to analyze the relative position of the slide. The reason for slide movement and stabilization measures are suggested for active slides. For problems of bigger magnitude and critical in nature expert opinion is also taken. Figure 7 shows a comparison of the same landslide in pre and post monsoon seasons.

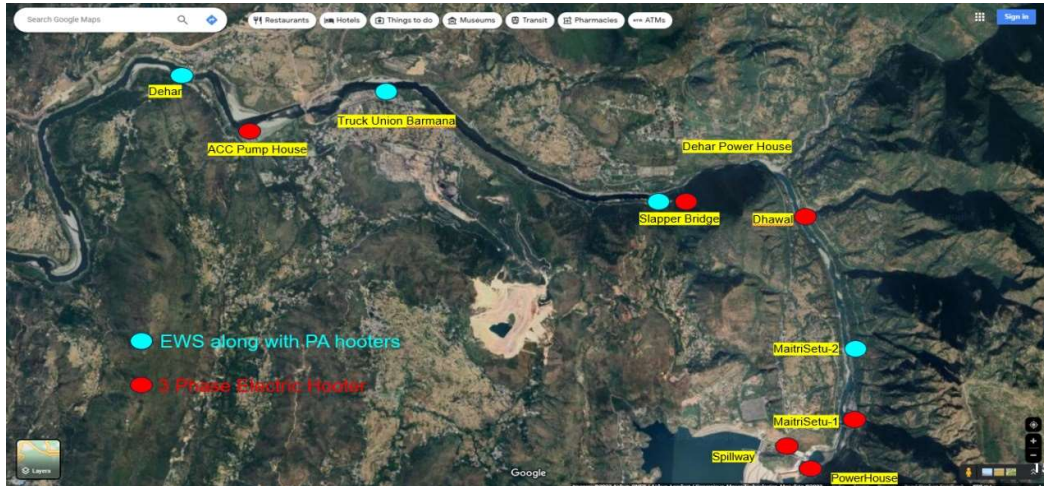
Figure 10 depicts the layout of downstream Early Warning system (EWS) consisting of real time PA system with electrical hooters. Early warning for routine plant operation discharge and spillway operation both are being disseminated to common public by various means like hooter systems, PA system, announcement vehicle, SMS etc.

Figure 10: Layout of Downstream EWS along with PA & Electric hooters

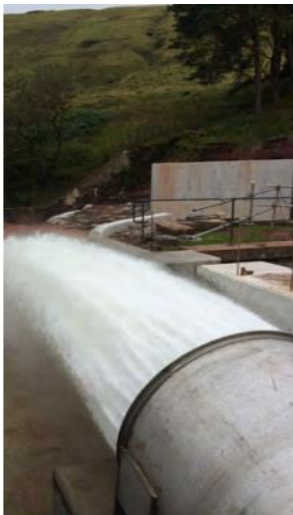
The original spillway had suffered repeated damage due to several incidents of discharge overflow. It was discovered that the spillway had insufficient capacity by modern standards and required a major upgrade.

One of the key points in this project was to minimise the water jet spread exiting the valve. Glenfield Invicta designed and supplied a remote stainless steel hood which was installed at the downstream end of the discharge valve to contain the jet of water and avoid the conical spray pattern associated with this valve type.

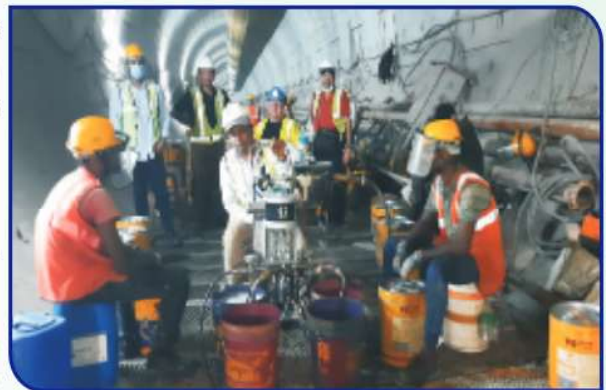
**Soil stabilization & water ingress control Job under execution by
M M A from July 2022 by Injecting 2Comp. PU Resin**

**CORE EXTRACTED FROM SOIL UP TO 6.5Meter BELOW AT ITD BOWBAZAR SHAFT
TO CHECK THE EFFICACY OF CEMENT -POLYMER GROUTING , 2-COMP
PUResin , ACRYLATE Gel GROUTING AS PER APPROVED METHOD STATEMENT**

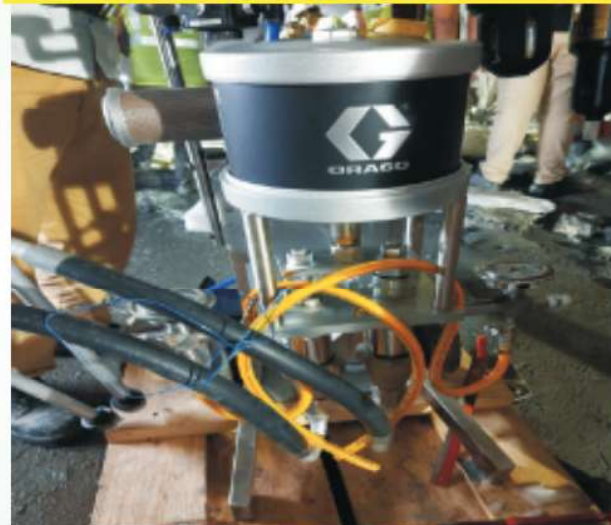
MMA Cement grout Pump 400litre capacity Screw Type pump, electrically operated . Attached with Accelerator Pumping arrangement in same frame& Fitted with VFD, RPM control for mixing and agitation.

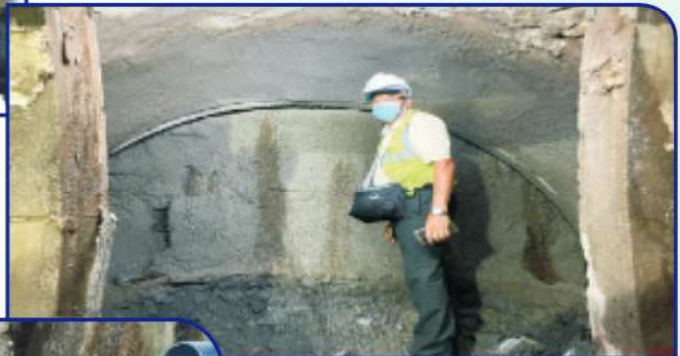
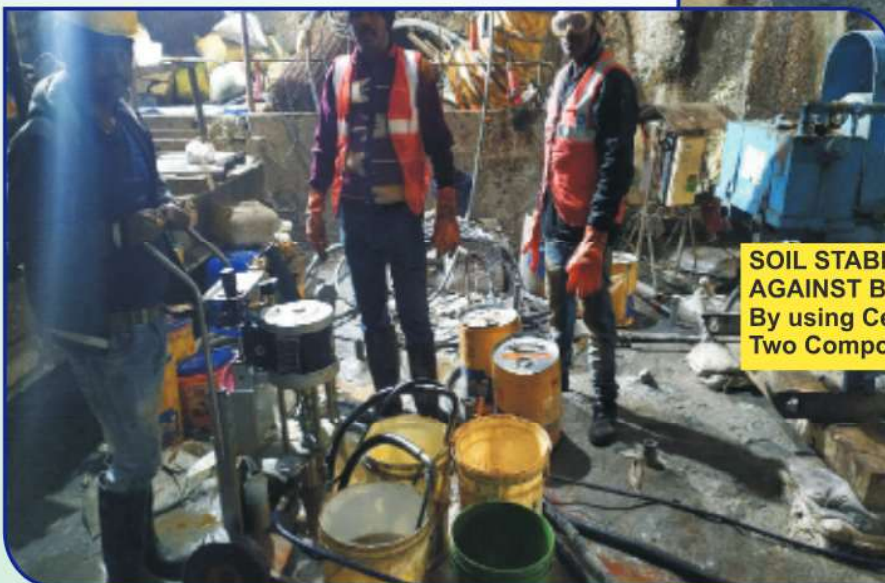
**SOIL STABILIZATION OF ITD BOWBAZAR SHAFT
AGAINST BOILING OUT OF SUBSOIL WATER
By using Cement Polymer Low viscous slurry and
Two Component PU resin & Acrylate**

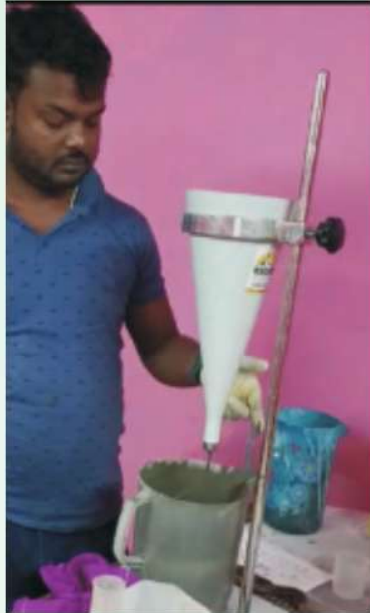
**WE ALSO PREPARE
DESIGN MIX OF CEMENT GROUT
AS PER SOIL CONDITION**

**DESIGN MIX OF CEMENT
GROUT FOR SOIL
STABILISATION AT
KMRCL BOWBAZAR
SHAFT Laboratory testing
for designing
Low viscous ,
chemical resistant
Cement, SBR Polymer +
HRWRA Grout Mix
testing with the
Tunnel soil &
Dirty alkaline water
To check its
suitability for injection
and efficacy at
project site laboratory**

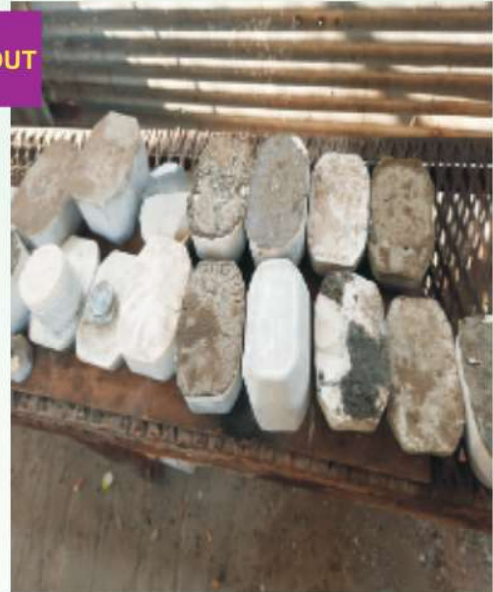
**MMA always do prior testing of Grouting materials at their laboratory and at site Laboratory
in ambient Temperature to check the suitability of propose Injection Grouting materials.**

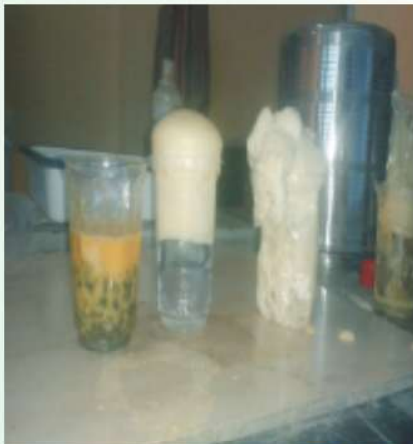
**Laboratory testing of Grout
materials by MMA
before any selection:
PU Resin, Acrylate,
Colloidal Silica
for soil stabilization
other than cement grout.
Using Tunnel soil &
water To check its suitability for
injection and efficacy at project
site laboratory**

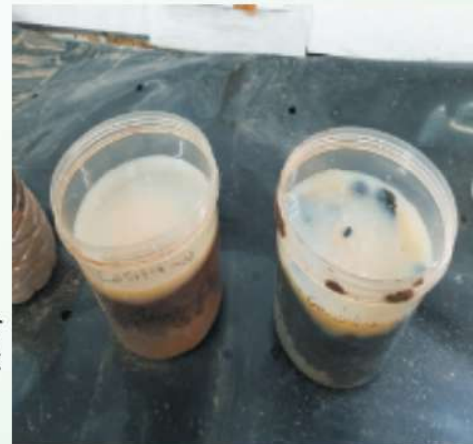
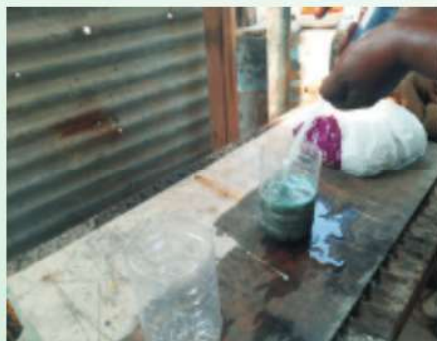
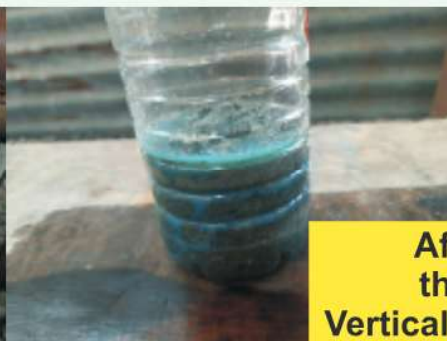
**After Acrylate Grouting ,
the Stabilized soil mass
Vertically standing and no collapse**
